Operator Dies after Excavator Tips Over the Side of a Bridge into River

Investigation: # 08WA00101
Release Date: August 7, 2014
SHARP Report: # 52-31-2014

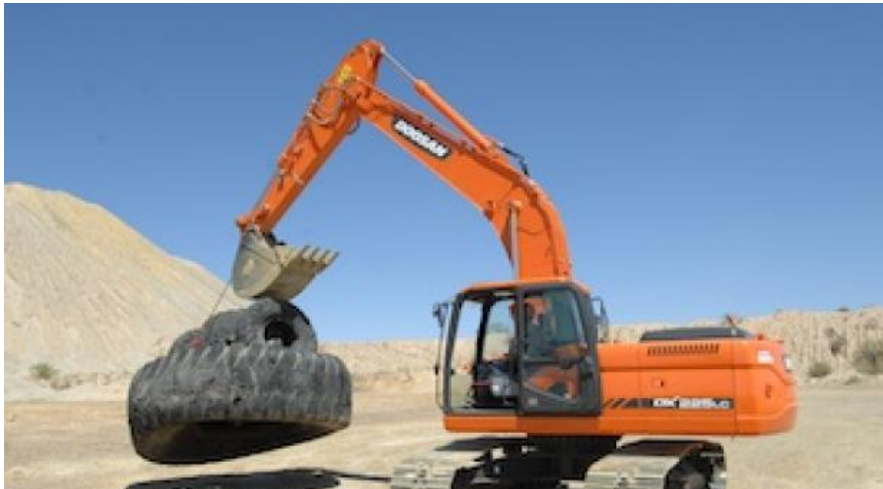
Photo 1: An excavator completing an over the side load test. Notice the cab and counterweight are perpendicular to the tracks

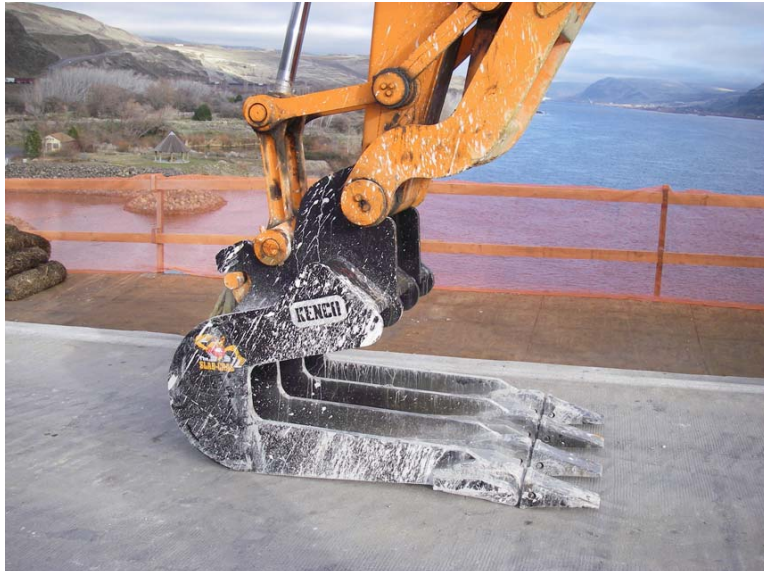
The excavator was fitted with an attachment called a Slab Crab. The Slab Crab is a 42 inch bucket manufactured by Kenco (model EX250) weighing 3,000 pounds and capable of moving slabs of concrete up to 12 inches thick. According to Kenco's website (<http://kenco.com/products/slab-crab>), Slab Crabs are specifically designed for concrete slab removal projects and are available for various sizes and types of machinery. Models are available for 20,000 – 150,000 pound excavators, as well as backhoes and skid steer machines.

Photo 4: Slab Crab bucket attachment

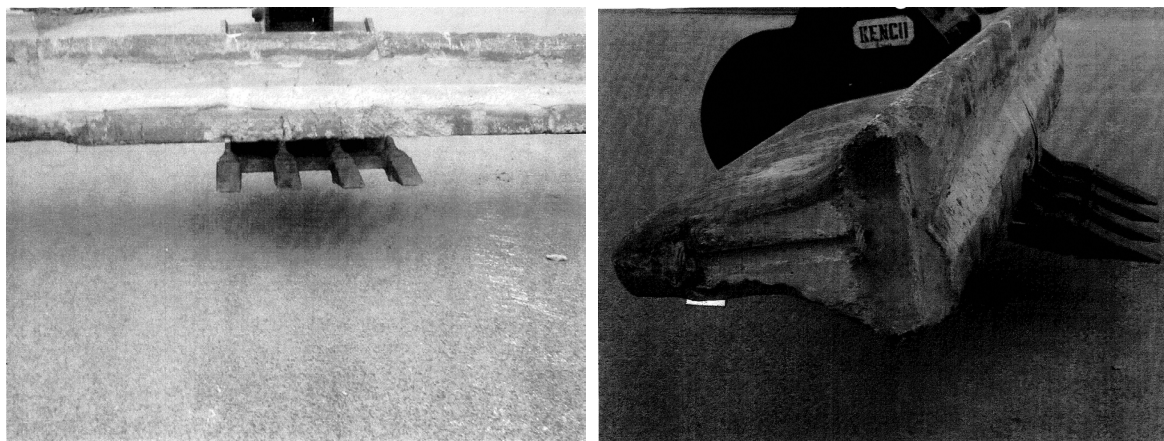
According to the employer, the operator was present at the time of the load testing of the excavator with a section of a concrete Jersey barrier weighing 6,140 pounds. The load test consisted of an operator moving the Jersey barrier 25 feet over the front of the excavator from center as well as 20 feet to the side with the Slab Crab attachment. The excavator was stable in both instances. The project engineer and project superintendent told the operator that while performing picks it was important to keep the load as close as possible to the excavator to maintain its stability. On the day before the incident, two project safety officers observed the operator doing picks and saw no safety concerns with how he operated the excavator.

Photos 8&9: Front and side view of Slab Crab during load testing with a concrete Jersey barrier
