**REPORT#:** 24KY022

**REPORT DATE:** July 31, 2024

## Manufacturing Laborer Falls from Elevated Pallet, Succumbs to Injuries

# KENTUCKY

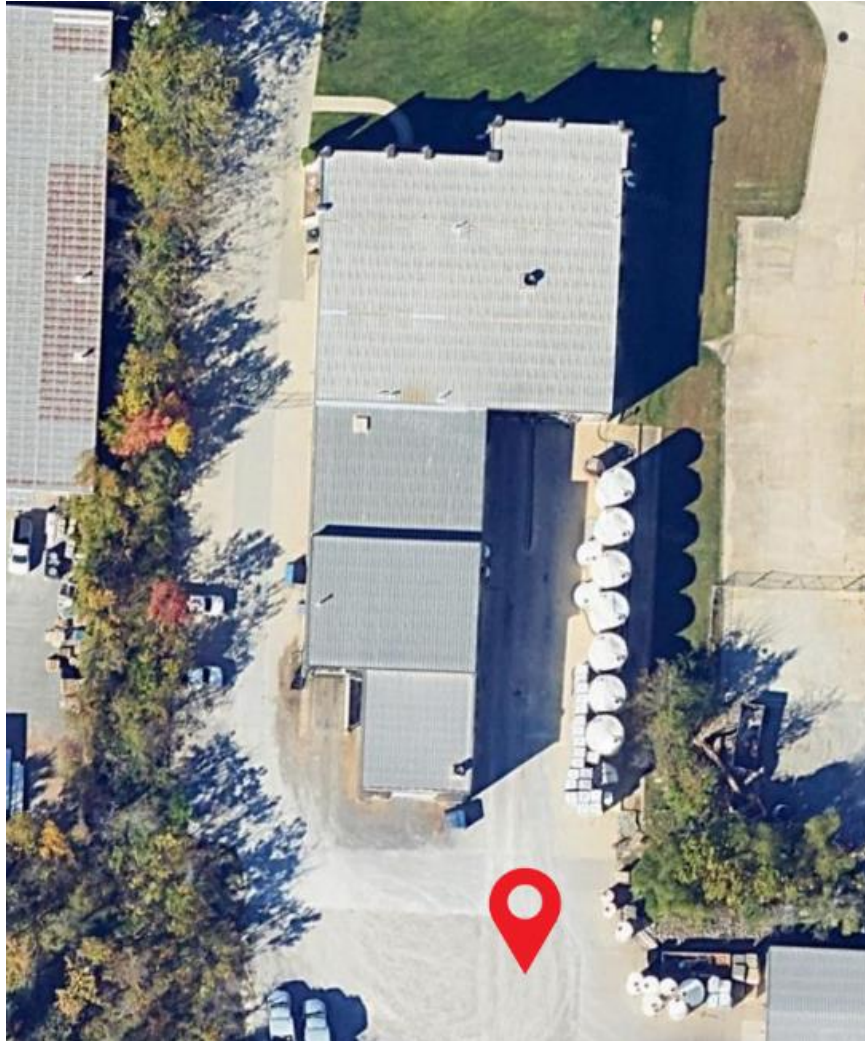
The incident occurred on a partially paved and level lot located at the rear of the additive manufacturer’s facility (photo 1). The facility itself, where the additives are produced, is an 18,000-square-foot metal building. The building sits on a 3-acre lot that is also utilized for parking and storage of polycarbonate tanks. The facility is in a largely industrial area outside the city limits of a major metropolitan area.

Photo 1. Overhead Google Earth image of manufacturing facility where the incident occurred. Red location maker indicates approximate location of the fall.
