Volunteer Fire Chief Dies in Motor Vehicle Incident While Responding to a Fire Alarm – Maryland

Fatality Assessment and Control Evaluation Investigation Report # F2009-12

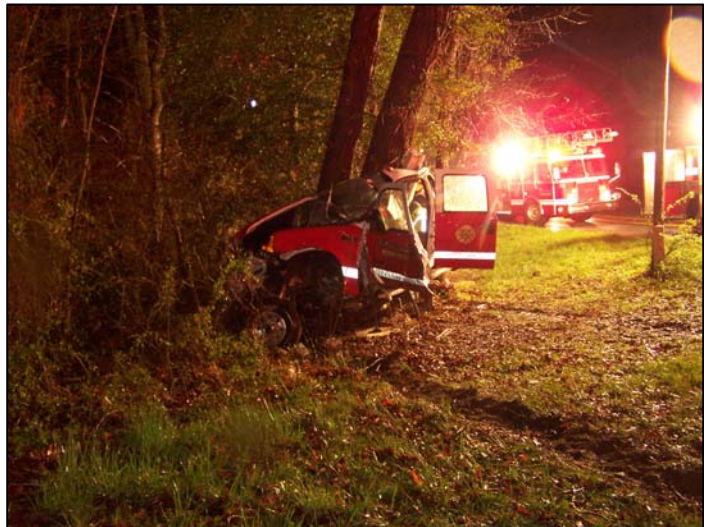
On April 15, 2009, a 41-year-old male volunteer fire chief (the victim) was fatally injured when the vehicle he was driving skidded off the highway and struck a tree. He was driving the fire department's response vehicle (pick-up truck) to a fire alarm when a car pulled out of an intersecting roadway to his left and across the path of his vehicle. The victim tried to maneuver his vehicle around the car, but his vehicle turned sideways and skidded down the highway. The vehicle then went off the highway and struck a tree. An eyewitness

Key contributing factors identified in this investigation included vehicle speed, wet roadways, operating the vehicle without the use of a siren, and an obstructed view at the intersecting roadway.
