A report from the NIOSH Fire Fighter Fatality Investigation and Prevention Program

November 1, 2017

Volunteer Fire Fighter Dies in a Floor Collapse While Working Above a Residential Basement Fire—South Dakota

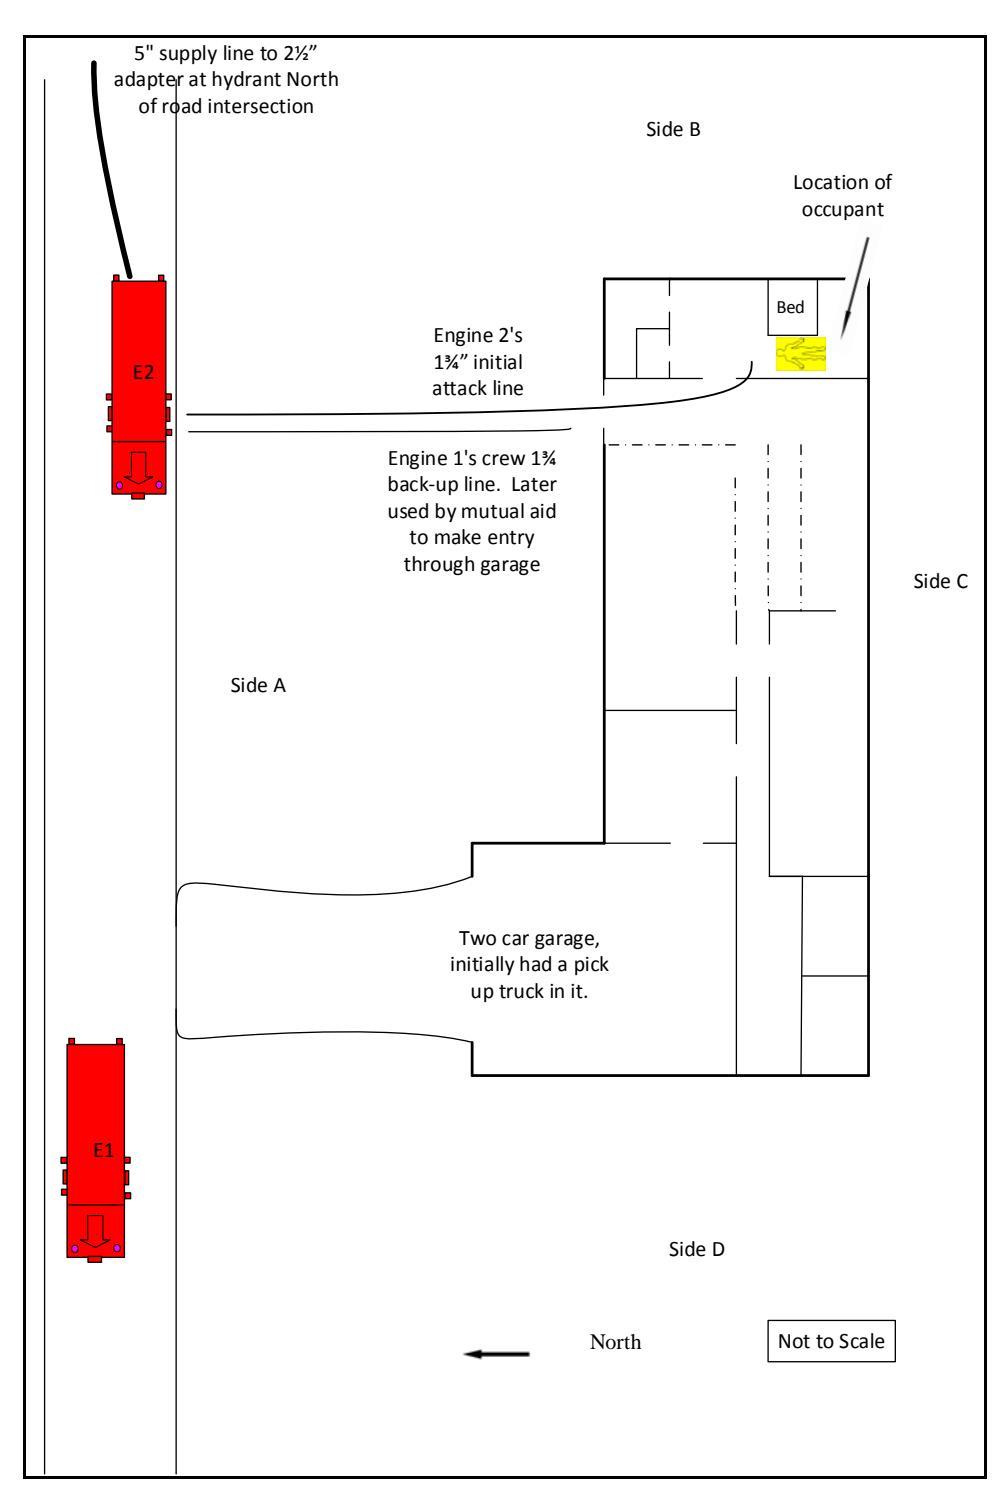
At 22:19 hours, Rescue 1 arrived on-scene. The Engine 2 crew searched the bathroom then heard erratic breathing and located the homeowner on the floor near the bed (see Diagram 3). The crew tried to move him but he was stuck and their low-air alarms were going off. The crew left the nozzle near the victim, and as they met the Engine 1 crew at the door, they told the Engine 1 crew to follow the hoseline to the occupant.
