Career Fire Fighter Dies and Another is Seriously Burned Fighting Arson Fire at a Commercial Strip Mall — Texas

Executive Summary

On May 18, 2017, a 31-year-old male career fire fighter died after fire conditions rapidly deteriorated inside a commercial strip mall.

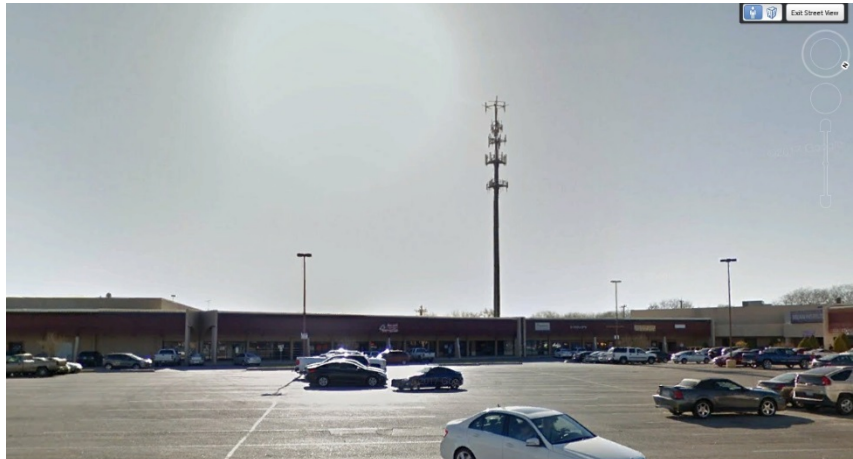
Street view of commercial strip mall where 31-year-old career fire fighter died.

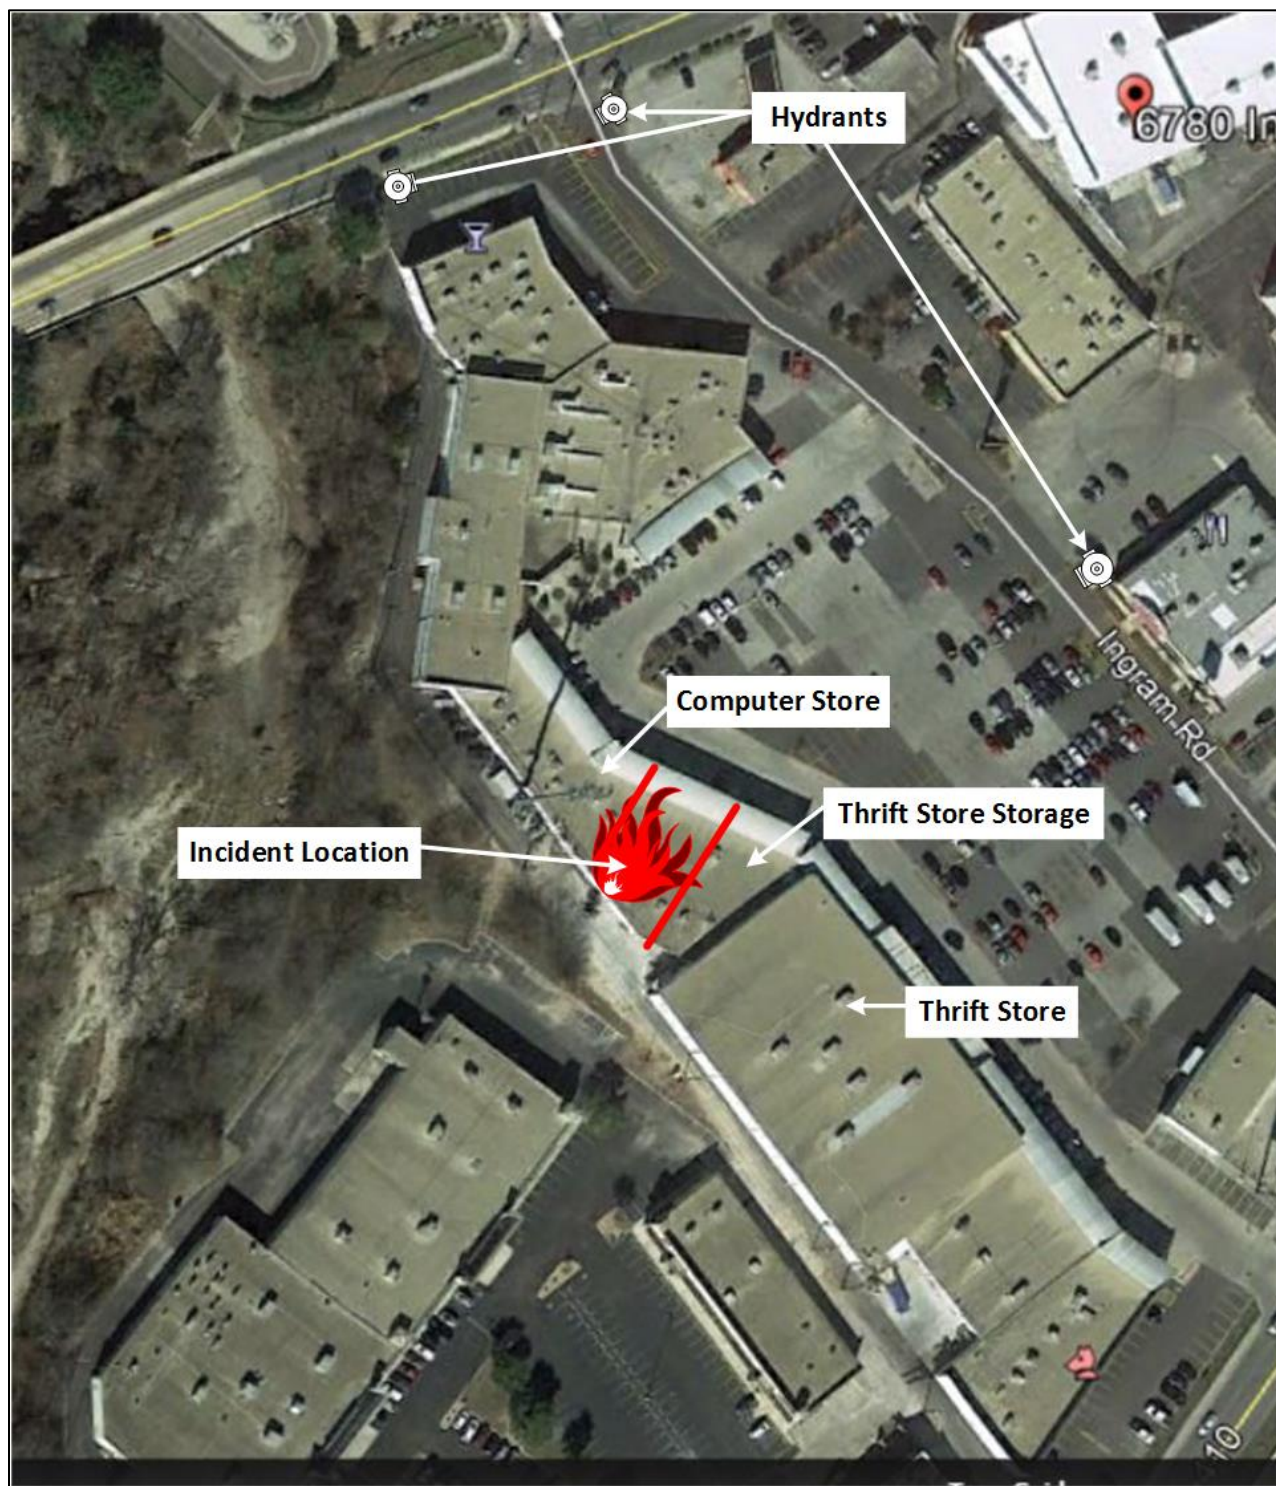
This incident occurred in a large, one-story, strip mall located in a commercial section of the city (See Photo 1) that enclosed approximately 86,000 square feet of floor space. The strip mall was constructed in a north-west to south-east orientation with a large parking lot located to the east. The strip-mall building contained a number of businesses including a thrift store and various businesses that sold cell phones, computers, a barber shop/beauty salon and other types of products. Other businesses in the strip mall complex not attached to the fire building included a retail tire store, restaurants and a nightclub. Some of the individual stores in the strip mall were vacant or used for storage. The thrift store included a dry stand-pipe with a Siamese Connection at Side Alpha.

Photo 1. Satellite overhead view showing large strip mall where incident occurred.
(Photo adapted from Google Earth)

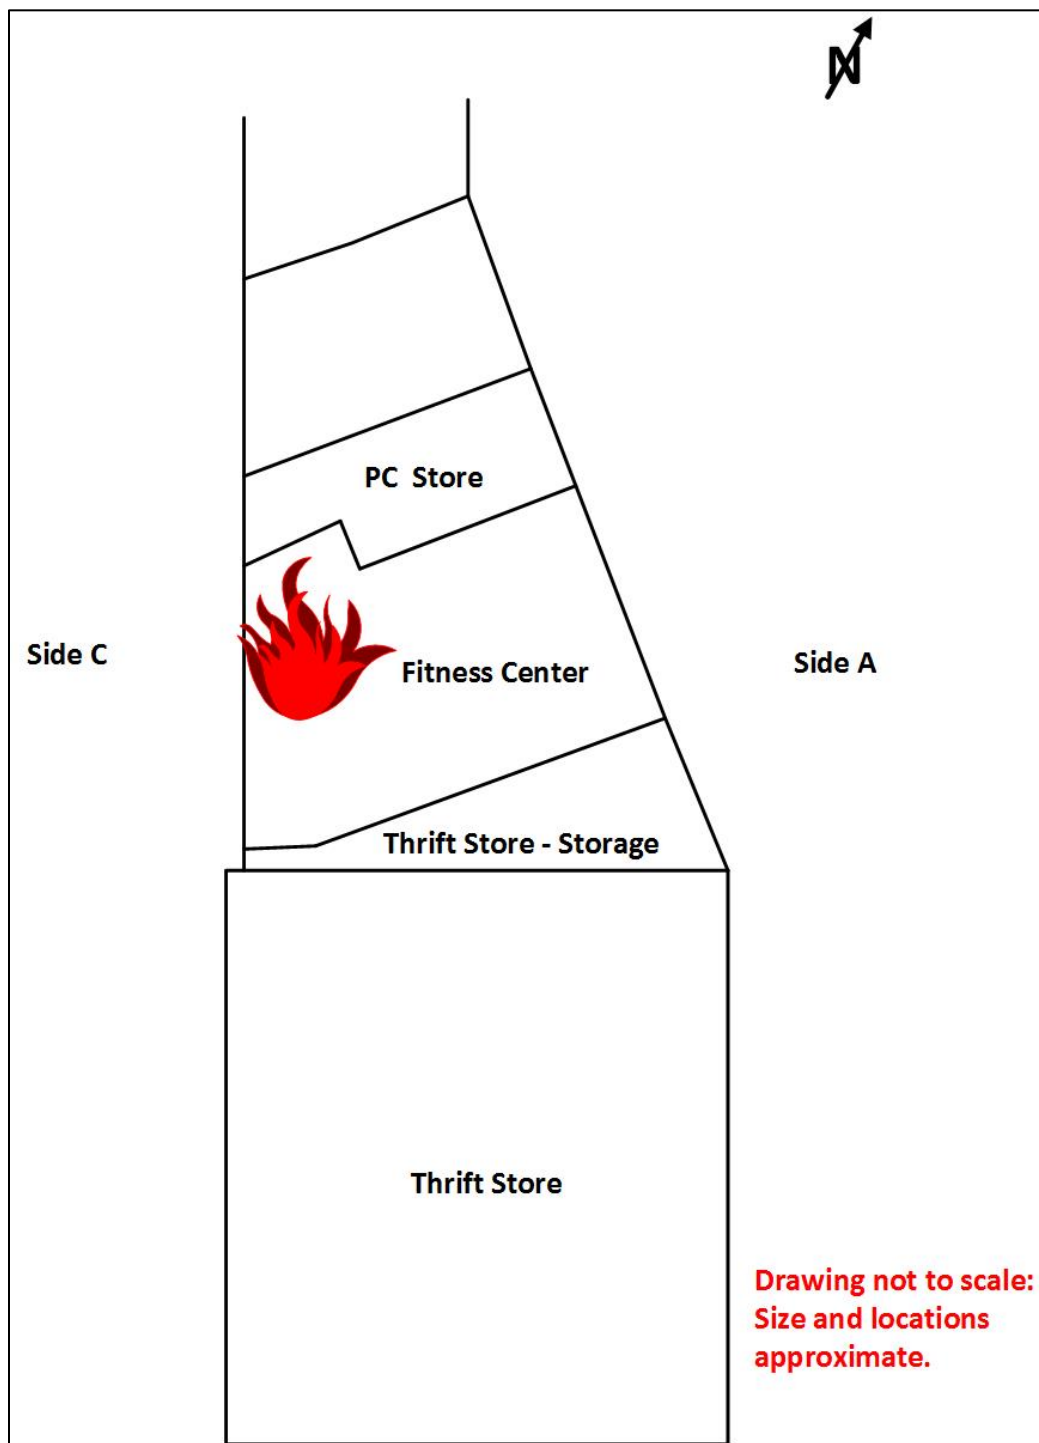
The fire structure was a single-story structure that housed an exercise gymnasium and personal fitness / training business located near the center of the main strip-mall structure. (See Photo 1 and Diagram 1). The Side Bravo exposure was vacant and being used by the thrift store as a storage facility for used clothing and personal items. The Side Delta exposure housed a computer retail and repair business.

Diagram 1. Approximate layout of strip mall in area where incident occurred.
(Diagram by NIOSH)
