Death in the line of duty... TIOS

A report from the NIOSH Fire Fighter Fatality Investigation and Prevention Program

Career Firefighter/SCUBA Diver Drowns While Searching for Civilian in an Industrialized River—Illinois

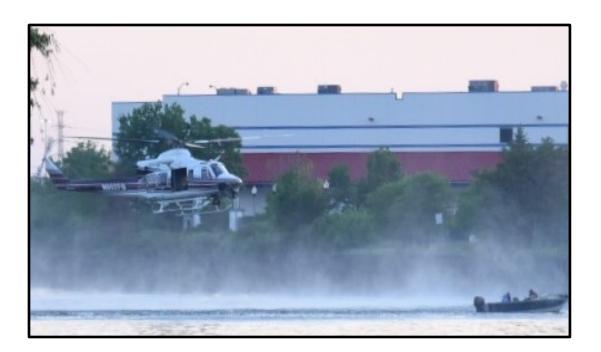
Helicopter makes approach to deploy the divers. (Courtesy of the fire department.)

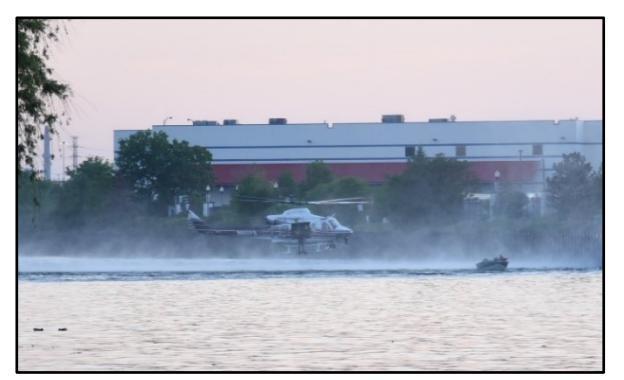
At 2001 hours, Squad 1 arrived on scene just as Helicopter 682 deployed two divers while hovering about 10 feet over the river and 20 feet south of the boat (see Photo 2). Diver 1 deployed first. Tapping the top of the head, Diver 1 indicated an okay status and moved to the west so Diver 2 could deploy. While enroute, the two divers had determined that Diver 1 would serve as a stationary underwater line tender, while Diver 2 would search in a circular pattern tethered to Diver 1.

Photo 2: Helicopter 682 makes approach to deploy the divers. (Courtesy of the fire department.)

Both divers swam to the civilian boat to obtain the last-seen point from the missing civilian's party. *Note: Sixteen minutes after initial 911 call, Helicopter 682 headed to the local airfield to refuel, leaving two divers from the helicopter in the river with no support vessels close by to block the river and ensure the safety of the divers from potential boat/barge traffic that could have endangered the divers.*
