Decontamination of Building Materials Contaminated with Methamphetamine

John W. Martyny, Ph.D., CIH
Associate Professor
National Jewish Medical and Research Center
Division of Environmental and Occupational Health Sciences

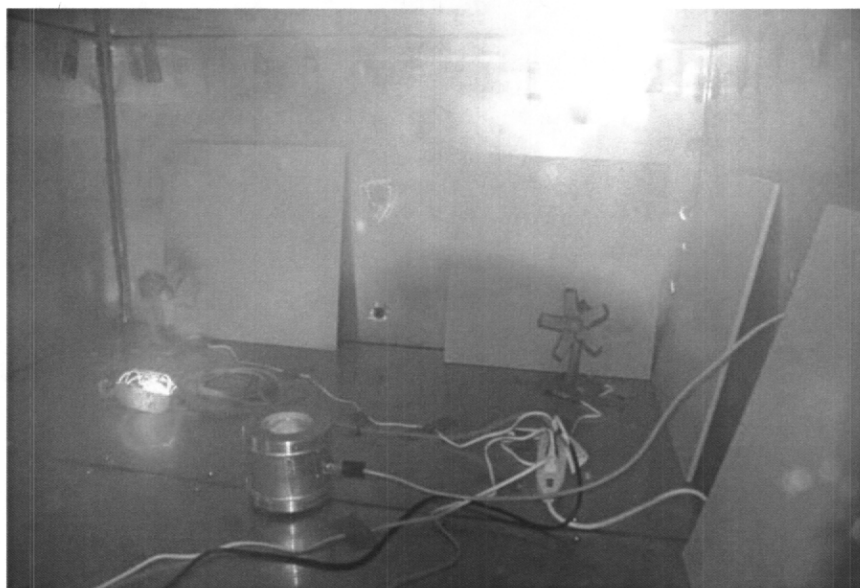
Figure 2. Painted drywall material being contaminated within the chamber.

After painting, the plywood panels, the drywall panels, the metal and the glass panels were put into the chamber for contamination. Each of the materials were put into the chamber at different times and using different amounts of methamphetamine (although all were approximately 200 mg). The contamination information is as follows:

The methamphetamine utilized for contamination was a street-manufactured methamphetamine provided by the North Metro Task Force in Colorado. The drug was approximately 77% methamphetamine and also contained small amounts of amphetamine, ephedrine, and pseudophedrine. No MDMA or phenylpropanolamine were found to be present. The methamphetamine was put into a beaker and the chamber was sealed and the methamphetamine aerosolized in the chamber. The methamphetamine was completely aerosolized within a short time (listed above) and the beaker heater was turned off. The fans within the chamber were kept running for another period of time to assure even distribution of the methamphetamine. The chamber was then allowed to sit overnight and the material was removed the next day.

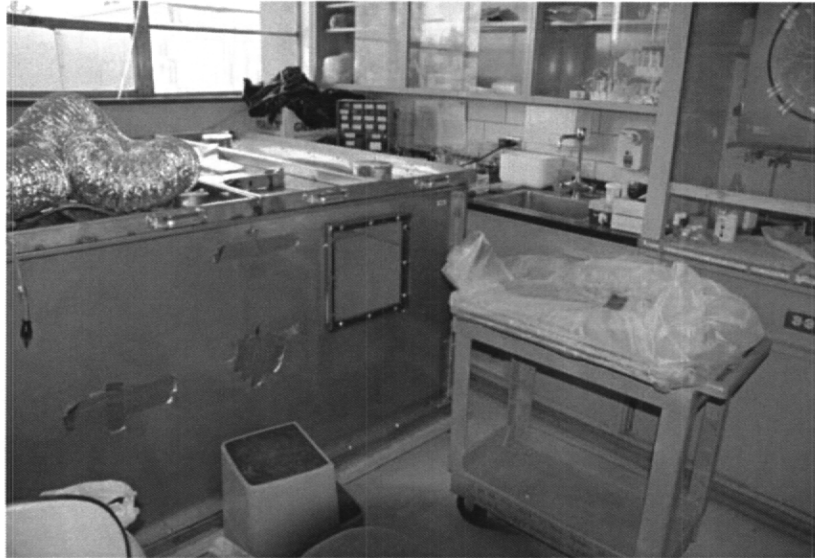
Figure 3. Drywall being removed for transportation to an area to be sampled and treated.

After the material was removed from the chamber, it was placed in a plastic bag and transported to an area to be pre-sampled, washed, and post sampled.
