Architectural Design and Construction

Instructor's Manual

DEPARTMENT OF HEALTH AND HUMAN SERVICES
Centers for Disease Control and Prevention
National Institute for Occupational Safety and Health

DHHS (NIOSH) Publication No. 2013-133

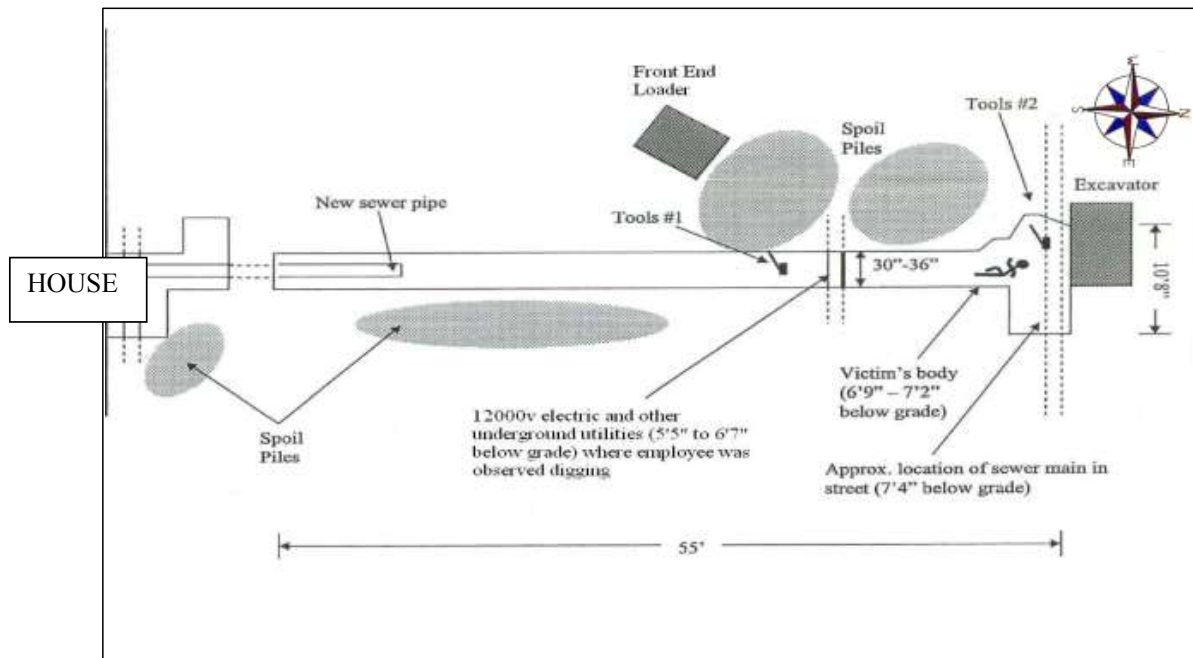
Figure 1: Schematic of the excavation and the incident site (courtesy of OSHA)

The GC left the work site to purchase the correct parts, while the excavation continued. The dimensions of the final trench were approximately 55 feet in length, 3 feet to 8 feet in depth, and 30 inches to 128 inches in width (see Figure 1). It was shaped like a “T.” The gravity sewer main that the victim was connecting to was located at a depth of 7 feet 4 inches (7' 4”) below grade at the east (E) end of the top of the “T.” Installation of new sewer pipe from the residence had been initiated and some of the trench had already been backfilled. The length of the trench from the top of the “T” to the location of the newly installed sewer pipe was 35 feet 11 inches (35'11”) at the time of the incident. Soil analysis results, conducted after the incident, indicated a granular, sandy gravel Type C soil (OSHA Excavation Standard) that contained large cobbles and boulders, the least stable soil type.

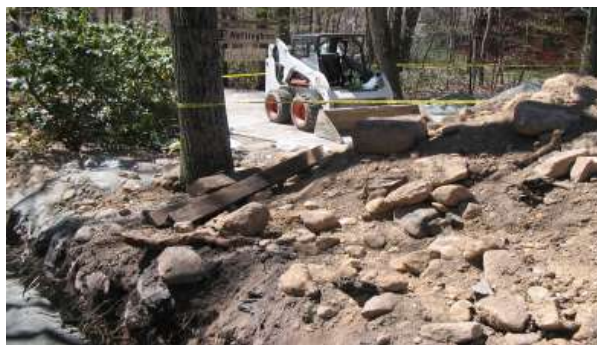
Figure 2: View of the west wall of the excavation south of the "T."
Note the boulders and loose rock/dirt on the excavation face as well as the location of the spoils pile within 2 feet of the edge of the trench. (courtesy of OSHA)

The faces of the trench were vertical. No shoring or benching was used. Large cobbles and boulders and loose rock/dirt were visible on the face of the excavation and were not removed or supported. The pavement above the E and W faces of the excavation had been undermined during excavation activities and no support system was utilized to protect employees from a possible collapse. Pieces of road pavement and asphalt had been undermined during excavation activities in the road in the proximity of the sewer main at the top of the "T." These areas were in plain view and did not have additional support. On the W side of the excavation, loose boulders, rock and debris in spoils piles were located less than two feet from the edge of the trench. (Figure 2) The excavator was positioned adjacent to the N end of the trench, where undermined areas were in plain sight. The N end of the trench, where the victim was installing the sewer tap, also lacked an access ladder or other safe means of entry/egress.

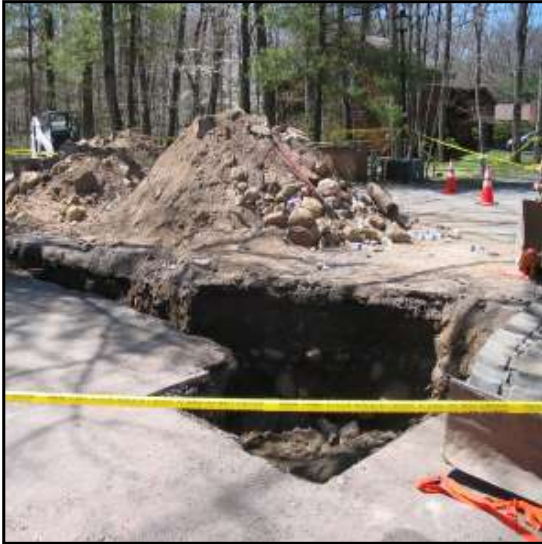
*Figure 3: Location of collapse.
Note spoils piles and equipment located less than 2 feet from the edge of the trench (courtesy of OSHA)*

The OSHA investigation resulted in findings that the trench section that collapsed was a triangular shaped area at the northwest corner of the excavation, approximately 5 feet 1 inch (5' 1") in length, 4 feet (4') wide, and 6-7 feet (6-7') deep. Multiple hazards were present, but had not been identified and remediated. The W side of the excavation collapsed and pieces of asphalt paving and rock fatally crushed the victim while he was making the sewer tap (Figures 3 and 4).

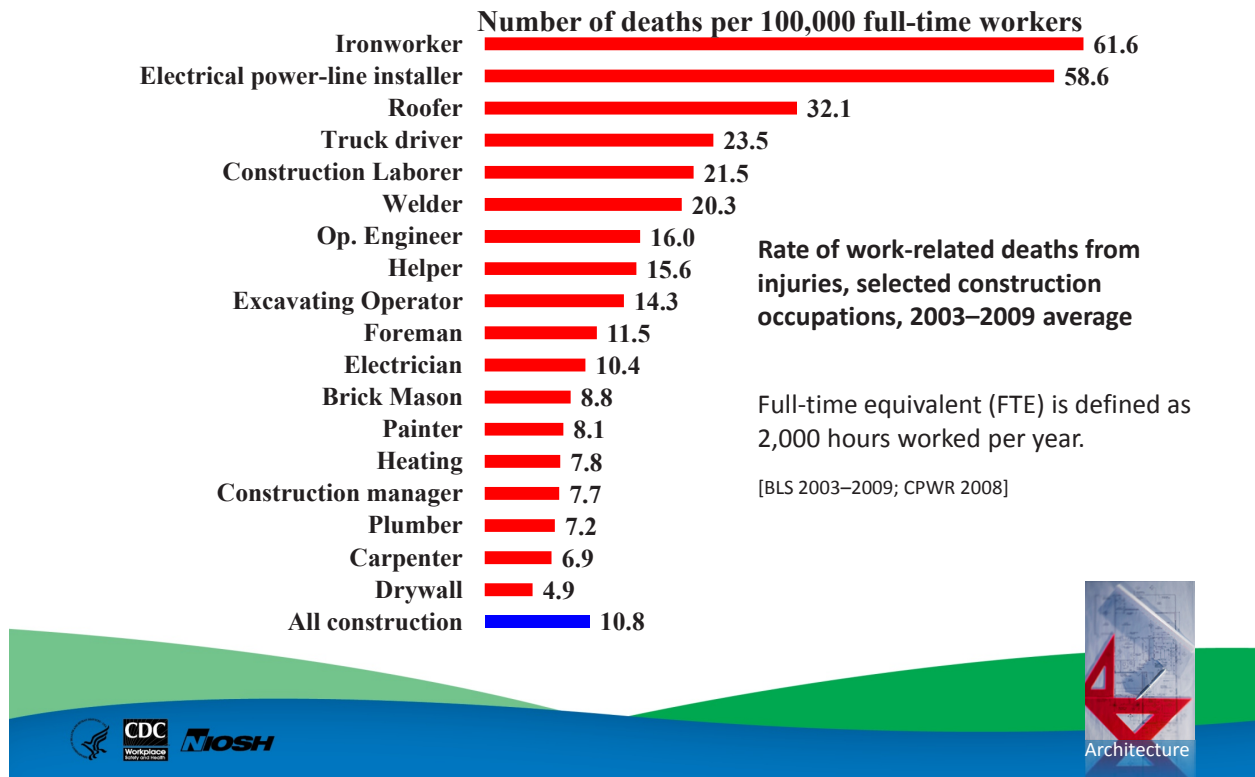
Death from Injury

The Center for Construction Research and Training compiles a “Construction Chart Book” using Bureau of Labor Statistics data [CPWR 2008]. It includes two illuminating charts useful for considering safety issues. This chart is compiled from 2003–2009 data on workplace fatalities. Ironworkers experience the highest work-related death rate, with 61.6 fatalities per 100,000 FTE.

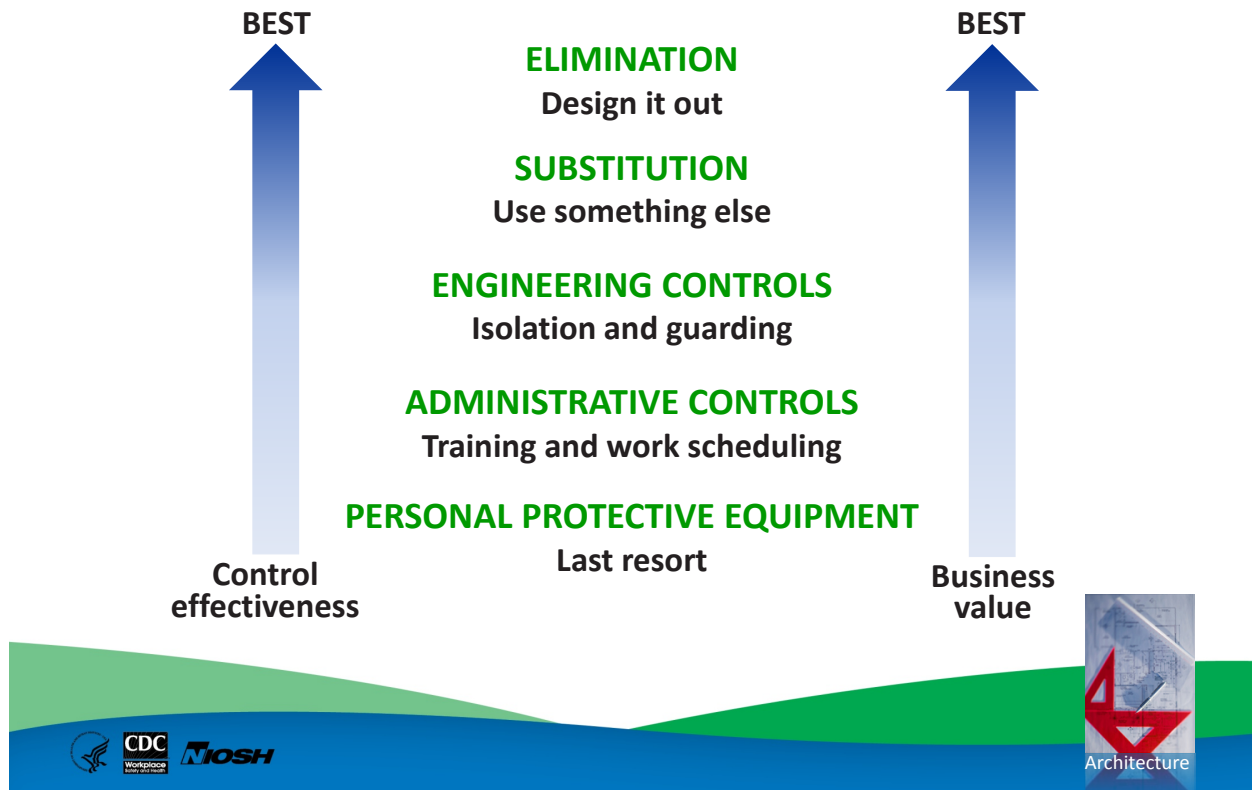
Hierarchy of Controls per ANSI/AIHA Z10-2005

This slide shows the well-accepted Hierarchy of Controls. PtD anticipates and removes potential hazardous elements at the design phase of a project through elimination or substitution. Residual risks may be minimized through the use of engineering and administrative controls.

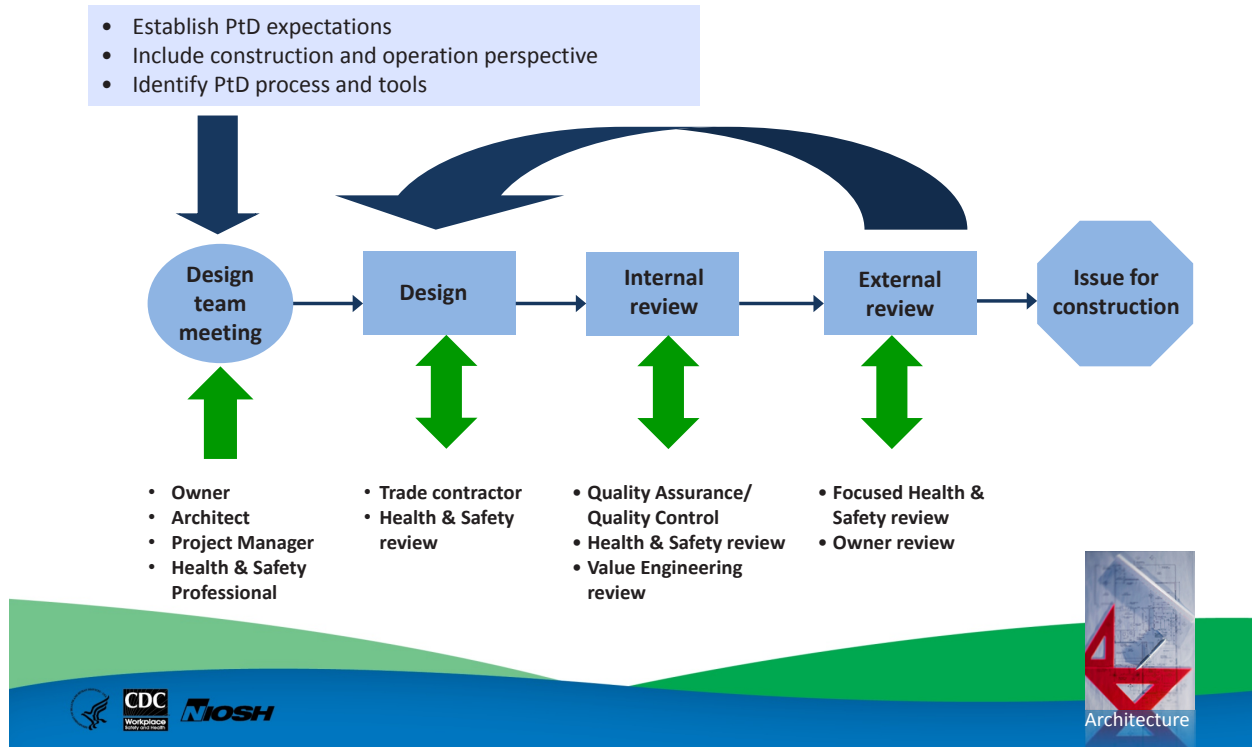
PtD Process

This graphic depicts the typical PtD process. The key component of this process is the incorporation of safety knowledge into design decisions. For example, site safety should be considered throughout the design process. A progress review specifically focused on site safety may be effective. Site safety knowledge can be provided by trade contractors, an on-site employee, or a hired consultant. The graphic emphasizes the importance of communication between designers and constructors. Such communication during design may reveal steps to reduce construction duration.

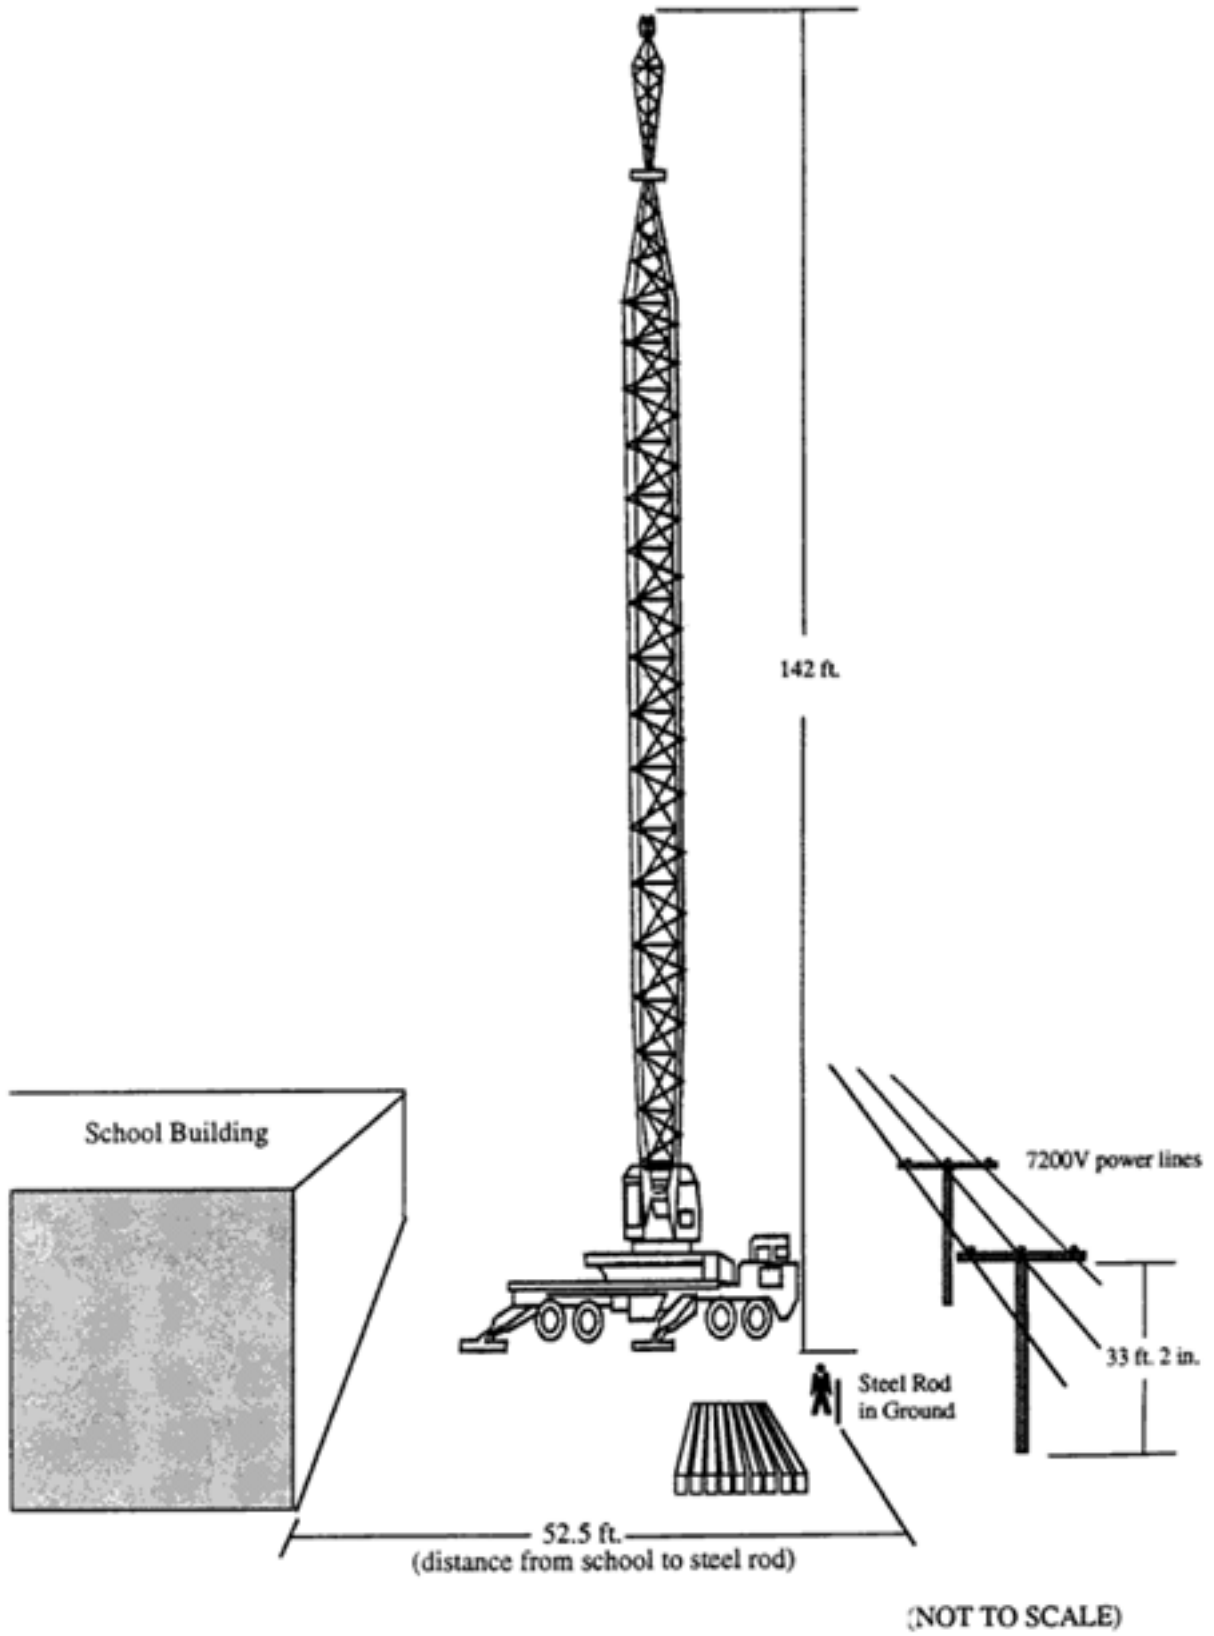
Figure Configuration of the Incident Site

During interviews immediately following the incident, the crane operator stated that he did not know how close the boom of the crane was to the powerline, since he was watching the ball at the end of the crane cable. The operator was maneuvering the ball so as not to hit the victim, who was 97 feet from the body of the crane. The cable's length from the end of the boom to the cable hook was 142 feet. It is assumed that counter forces on the cable--the boom swinging the cable in one direction and the victim pulling the cable in the opposite direction--caused the cable to whip into the powerline. Although the victim was standing 10 feet from the power pole, a scale drawing of the area demonstrates that with the crane positioned 11 feet from the powerline and its 190-foot boom positioned at a 70-degree angle with 142 feet of cable extended, the ball would be 10 feet from the power pole but only 5 to 7 feet from the powerline at 33 feet above ground level--the height of powerline.

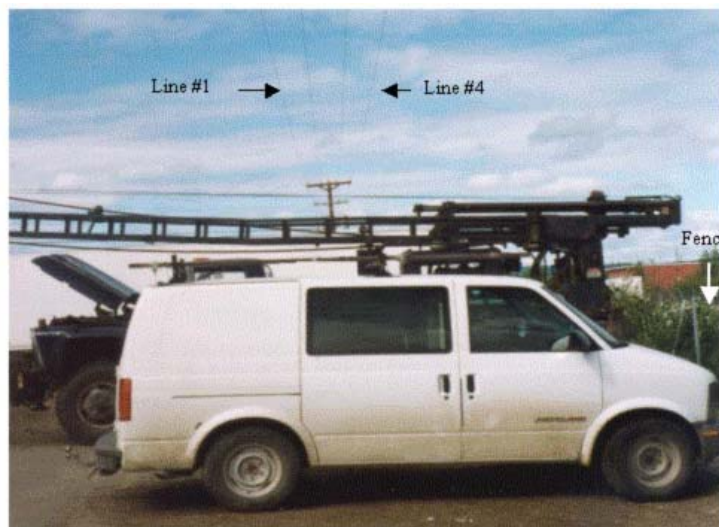
Figure 1. Location of van and drill rig under overhead power lines

The company was engaged by the contractor to drill three monitoring wells for the placement of equipment to collect ground water data. The incident site was an industrial lot at the corner of two unpaved roads. Two buildings were on the lot. The lot surface consisted of compacted dirt, crushed rock, and gravel. A ditch and a 6-foot chain-link fence separated the front of the lot from the road. The fence continued around the perimeter of the lot. Access to the lot was over a culvert and through an 18-foot chain link gate. An electric utility easement was located along the front of the lot parallel with the road. Poles supporting four lines were located outside of the lot; the nearest utility pole was near the intersection of the two roads. The power lines were parallel to the road, and all lines (#1, #2, #3, and #4) traversed above the lot. Lines #1, #3, and #4 were energized to 7,200 volts; line #2 was neutral. A crossbeam with 3-foot spacing between lines supported the lines. The horizontal distance from line #4 (closest to the road) to the fence was approximately 11½ feet ([Figure 1](#)). Weather may have been a contributing factor at the time of the incident; reduced visibility from rain and mild mist was reported. The lot surface was very wet with some puddling of water.

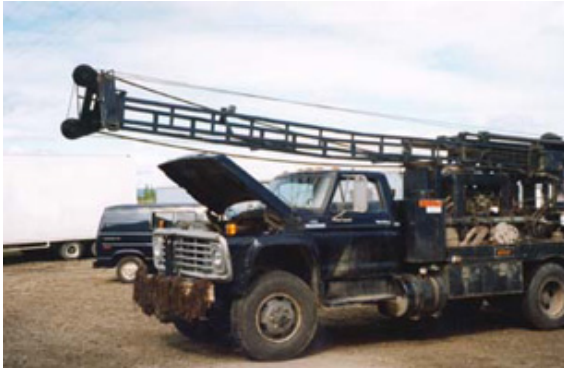
Figure 2a. View of drill rig, front driver's side

The equipment involved in the incident was a 1979 auger (mechanical rotary drill) mounted to a truck bed ([Figure 2a and 2b](#)). The truck was equipped with three outriggers: one at the front, mid-distance from both side; and two at the rear. The master derrick (or mast) was approximately 27 feet long with a maximum vertical rotation of 90 degrees from a rear pivot point 3½ feet from the end of the mast. The mast's pivot point was 8 feet above ground level. The height of the mast when fully raised was 31½ feet. All mast, drill, and pump controls were located at the rear of the truck. The control panel was in poor condition with worn and weathered labels ([Figure 2c](#)). An operator's platform consisted of a small metal grate attached to the rear of the truck below the control panel ([Figure 2d](#)).

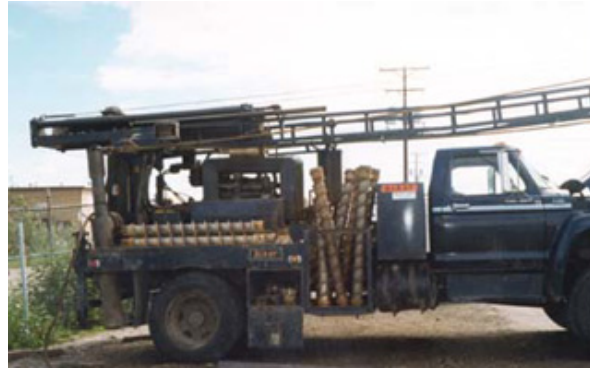
Figure 2b. View of drill rig, passenger side

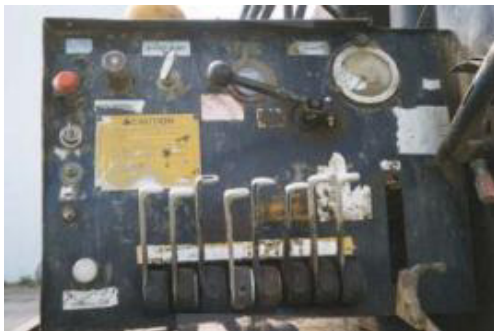
Figure 2c. Control Panel

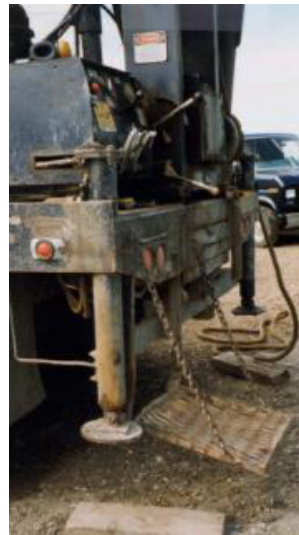
Figure 2d. Control Panel and operator's platform

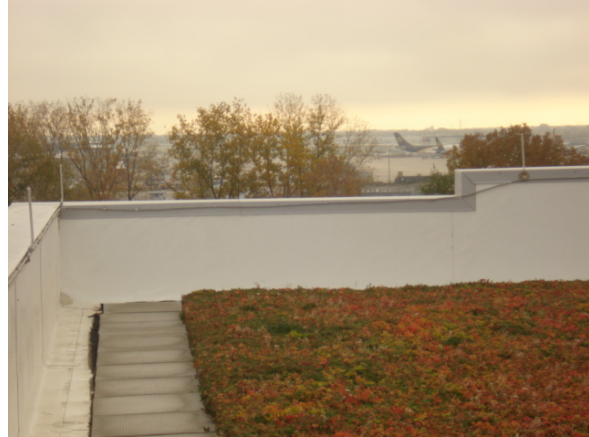
Parapets

The parapet will serve as adequate fall protection if it is at least 39" high.

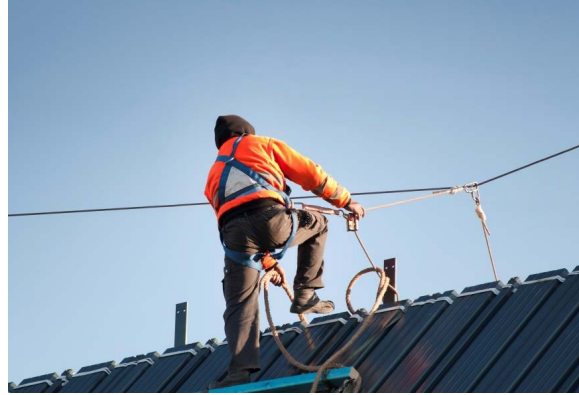
Anchor Points

- Part of the facility
- Use during construction and maintenance
- OSHA standard regarding anchorages can be found in 29 CFR 1926.502(d)(15)

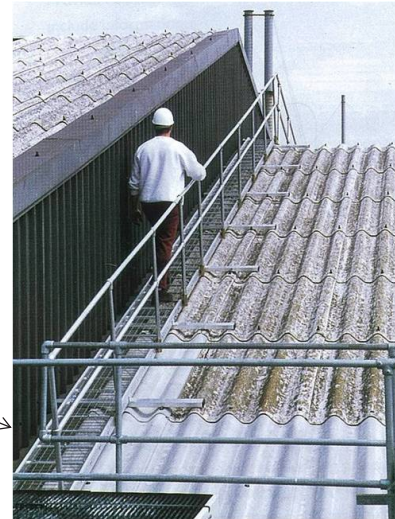
Walkway guardrails designed as a barrier from fragile materials

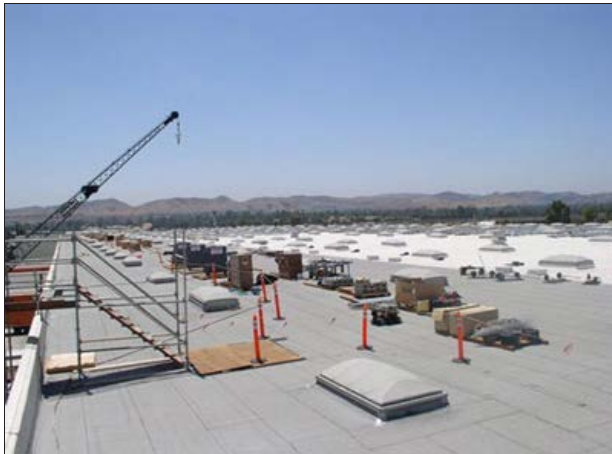
Exhibit 1. The rooftop looking south.

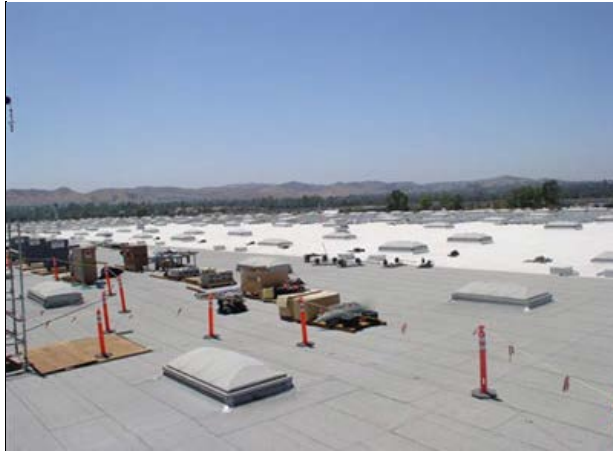
Exhibit 2. The rooftop looking west.

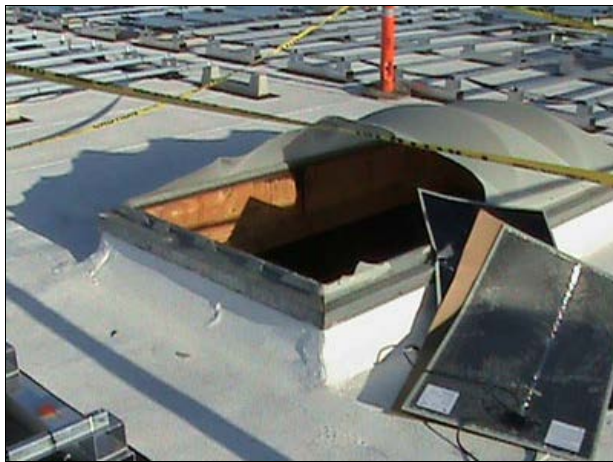
Exhibit 3. The skylight the victim fell through.

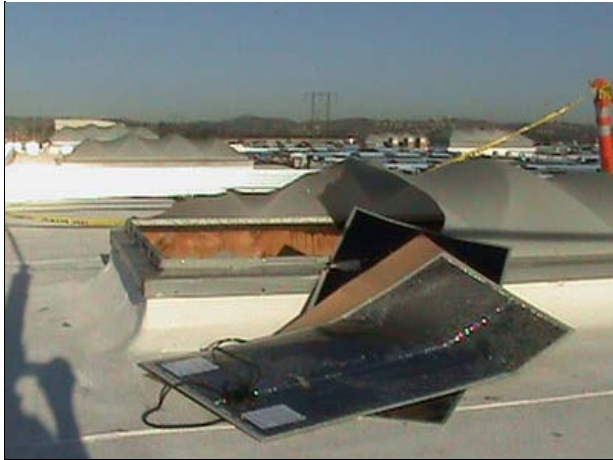
Exhibit 4. The solar panels that the victim was carrying when he tripped.

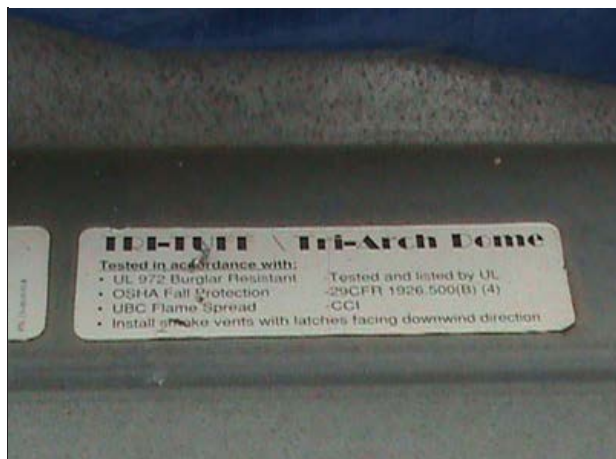
Exhibit 6. The identification tab on the skylight the victim fell through.

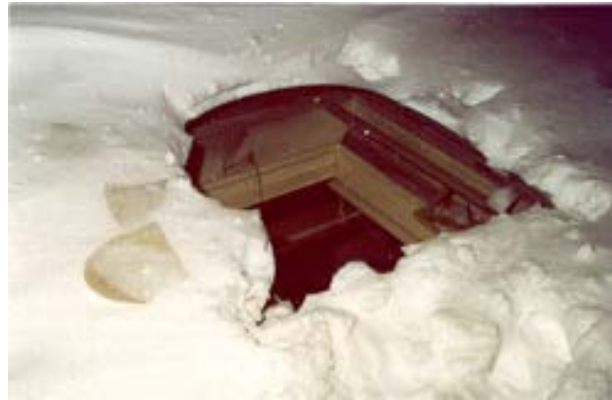
Figure 1. This picture shows the broken skylight where victim fell.

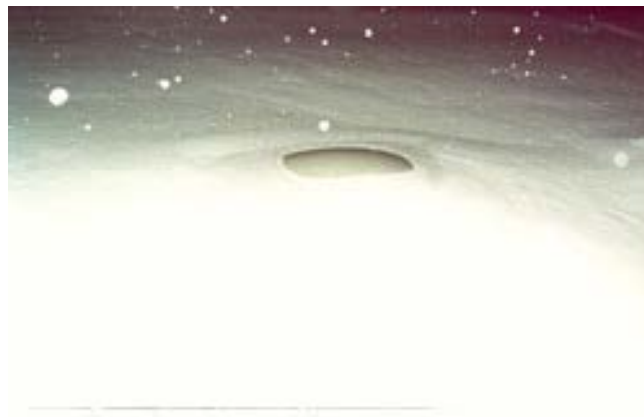
Figure 2. This picture shows an adjacent skylight, which was unguarded and snow covered.

Recommendation #1: Employers should guard skylight openings.

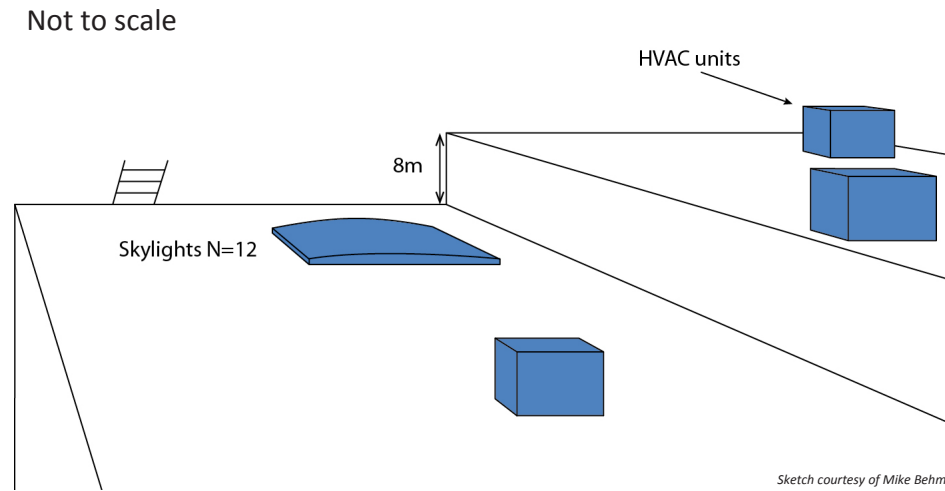
Sketch of Rooftop

Here is a sketch of the roof. Was the worker just unlucky?

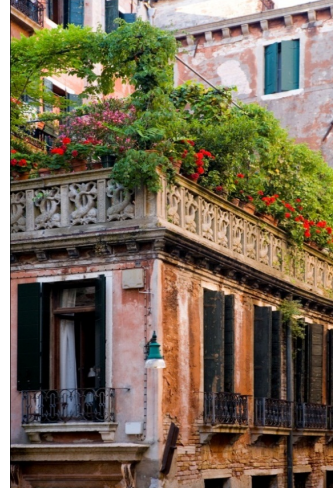
Safe Roof Garden

Garden rooftop patio with railings to prevent falls

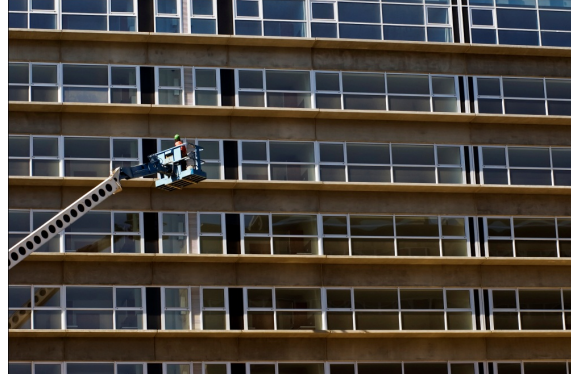
Window Access System

Safe access for cleaning and maintenance of the facility should be considered during the design phase.

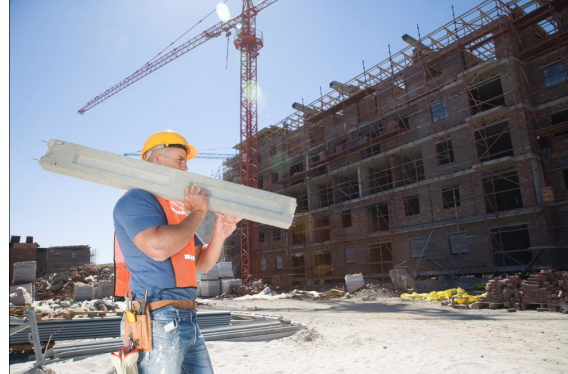
Material Handling

Heavy blocks are a significant musculoskeletal hazard, causing many injuries, but are an easy design issue to resolve.

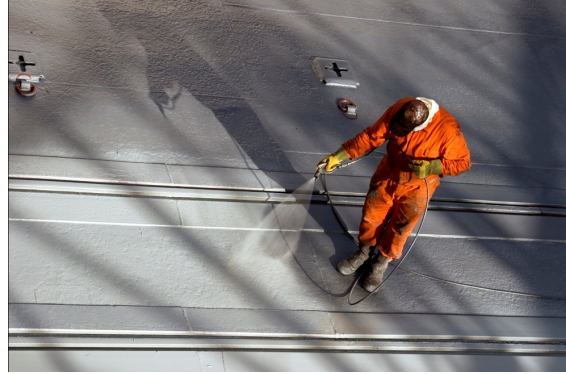
Surface Coatings and Finishes

- Why apply?
- Must be sprayed?
- Materials compatible?
- Working space?
- Ventilation?
- Pretreat materials?
- Handling issues?
- Access issues?
- Is there a need for respiratory protection?

This worker wears protection against finish hazards.
