Analysis of Safety Aspects And Mining Practices For Effective Ground Control in Surface Mining

Suresh K. Bhatt, *Mining Engineer*
Christopher Mark, *Supervisory physical scientist*
National Institute for Occupational Safety and Health
Pittsburgh Research Laboratory
Pittsburgh, PA.

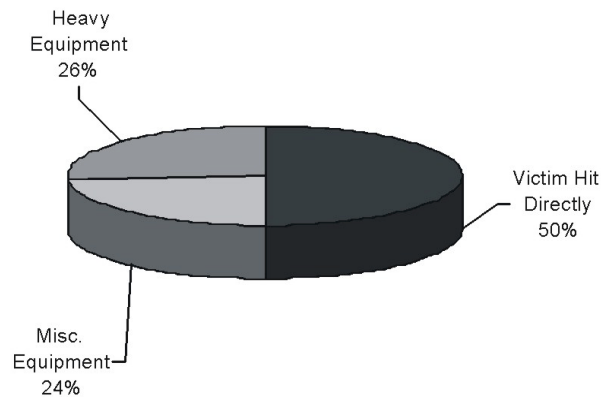
Figure 1. Accidents by worker involvement

Approximately 26% of all accidents caused by highwall failure involved heavy earth moving equipment, such as the drill, front-end loader, dozer, shovel/dragline, and trucks. Approximately half of the injuries were caused when the failed material hit the victim directly. The remaining 24% involved miscellaneous equipment items (over 40). Figure 1 shows this breakdown.

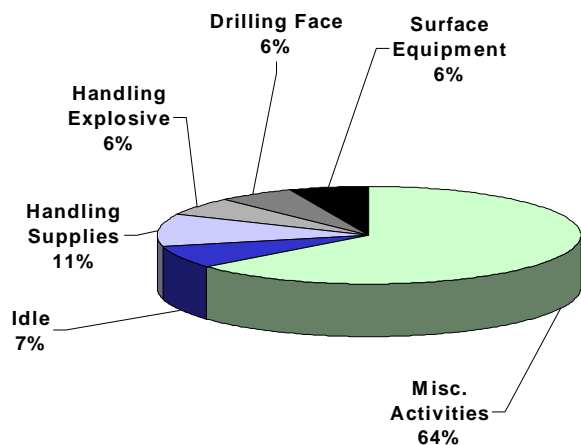
Figure 2. Accidents by worker activity

Handling supplies or material was found to be the single most frequent (11%) worker activity when injured, followed by idle category (7%). Handling explosives, drilling face, and surface equipment (not elsewhere classified) each represent about 6% of all accidents (18% total). The remaining 64% are distributed over 80 mine worker activities. Figure 2 shows this breakdown.

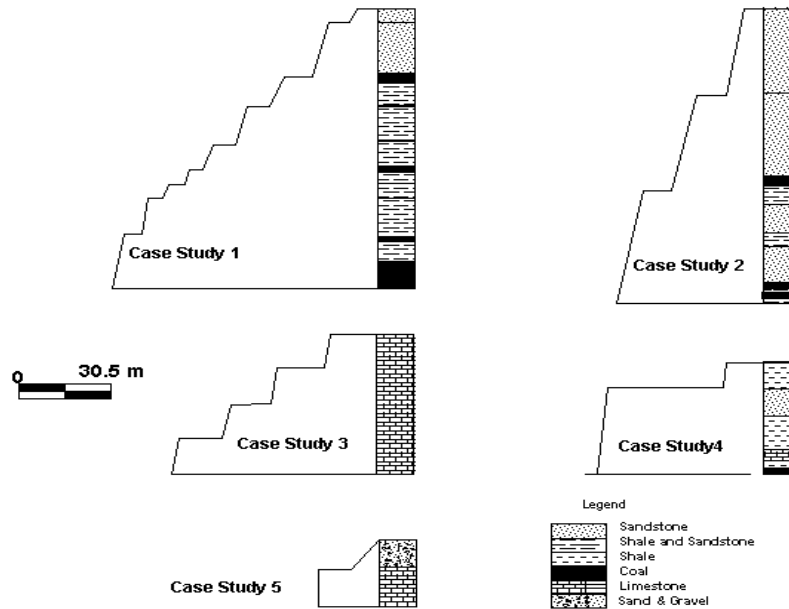
Figure 4. Geological settings and operational parameters

In addition to gathering information from the mine personnel, an operating surface mine was visited at each location. The mine visits covered parts of West Virginia, Pennsylvania, and Ohio. Materials mined include coal (anthracite and bituminous), limestone, and sandstone. Of the eleven mines, eight are coal, two limestone, and one sandstone. Figure 3 shows the general location of these mines in the eastern United States. Five case studies are provided to represent the mining practices and safety aspects of the study area. Typically, a case study addresses the geological setting and operational parameters (bench width, height, and slope angle) in a mining area for effective ground control. Figure 4 shows the geological settings and operational parameters for the five case studies.
