## Preventing Occupational Respiratory Disease from Exposures caused by Dampness in Office Buildings, Schools, and Other Nonindustrial Buildings

# 1 Preventing Occupational Respiratory Disease from 2 Exposures caused by Dampness in Office Buildings, 3 Schools, and other Nonindustrial Buildings

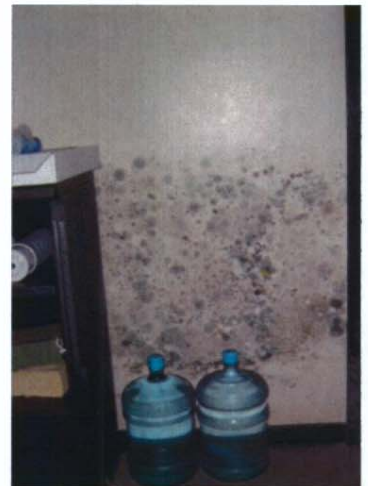
Mold growth on wall board.

20 Most buildings will periodically experience events that will contribute to  
21 excess moisture or water damage, such as roof leaks, window leaks, and  
22 condensation and leaks from pipes. Building materials such as wall board  
23 and carpets that become wet during leaks or floods will eventually  
24 deteriorate and can allow bacteria and mold to grow unless they dry  
25 quickly. Although some materials will require replacement due to any  
26 water or moisture damage, complete drying in less than 48 hours will  
27 prevent moisture damage and microbial growth in many wet materials  
28 [EPA 2001]. For this reason, building management should have policies  
29 in place that specify steps that will be taken to address rapid drying or  
30 replacement of building materials within 48 hours of becoming wet.  
31 Management should also identify and correct all sources of excess  
32 building moisture (e.g., roof and window leaks; inadequate drainage

33 around the foundation), as not doing so will increase the likelihood that  
34 building occupants will develop respiratory symptoms or disease, and  
35 costly repairs and remediation will be necessary in the future. Regularly scheduled inspections of the  
36 building by maintenance personnel (focusing on ceilings, dry wall and carpets adjacent to exterior  
37 walls, and basement areas) may help to identify evidence of leaks or dampness that can be  
38 addressed before extensive damage to building materials occurs (see Appendix A, Building  
39 Inspection Checklist). Management should encourage employees to report evidence of leaks or  
40 excessive building moisture (e.g., stained ceiling tiles; musty odors) to supervisors as soon as they  
41 become aware of the moisture.
