# Differential wall rock movements associated with rock bursts, Lucky Friday Mine, Coeur d'Alene Mining District, Idaho, USA

B.G. White & J.K. Whyatt

Spokane Research Laboratory, National Institute for Occupational Safety and Health, Wash., USA

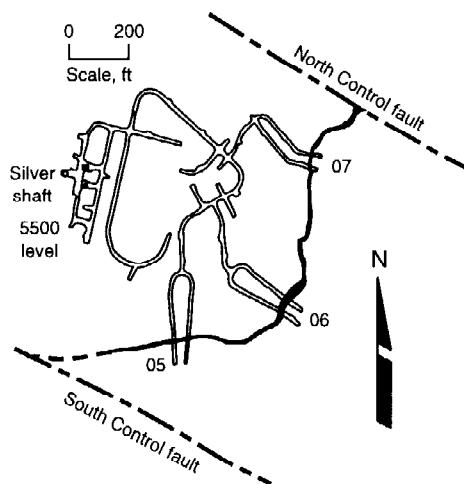
Figure 1. Plan view of Lucky Friday Mine, 5500 sublevel

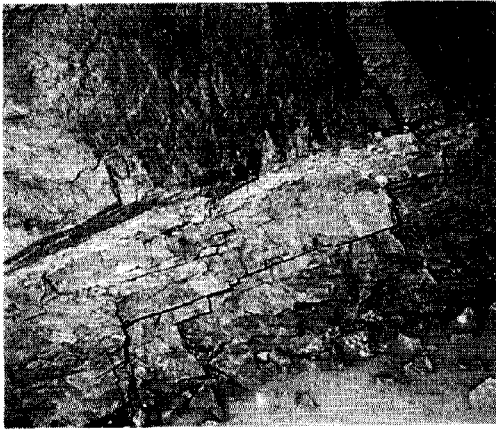
Figure 2. Soft, white gouge on slip plane in argillite interbedded in hanging wall rib.

Several types of recurrently seen structures are believed to indicate mining-induced wall rock movements. These structures include mining-induced thrust faults, or shear-ruptures; disrupted, mining-induced extension-fracture zones; and bedding plane faults containing a distinctive gouge. That is, in most cases, shear planes contain compact, gray or greenish-gray gouge. This color contrasts with the soft, white gouge found along bedding planes near active stopes and within inferred mining-induced shear ruptures

(Fig. 2). The presence of the white gouge in structures that are believed, for other reasons, to have been caused by mining and the absence of the white gouge at locations away from the ore body suggests that this gouge results from mining-induced slip.

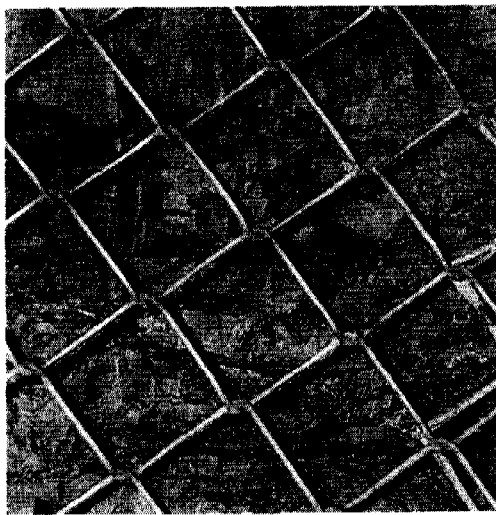
Figure 3. Mining-induced extension fractures in stope ribs.

Flat-dipping extension fractures are locally seen in the stope walls and in the advancing stope face (Fig. 3). These fractures are sometimes densely concentrated within zones 5 to 10 cm thick. Concentration of these fractures in the upper one-third of mining faces confirms that they are caused by mining and that they form in the immediate sill. Thin, tabular rock layers within these zones are occasionally broken, rotated, and disrupted (Fig. 4). Evidence of slip has been established by offsets of veins up to several tens of centimeters. Thus, these extension-fracture zones may evolve into flat-dipping thrust faults.

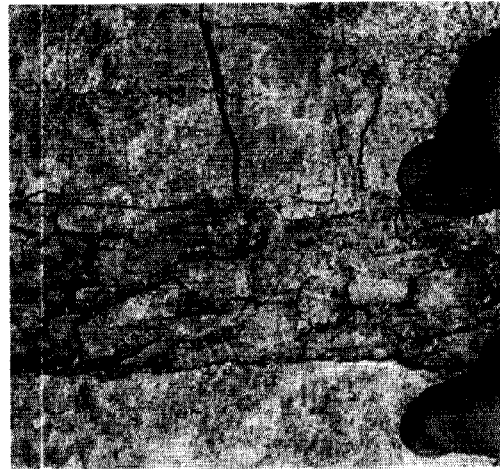
Figure 4. Disrupted zone of closely spaced mining-induced extension fractures indicating activation of zone as a flat fault.

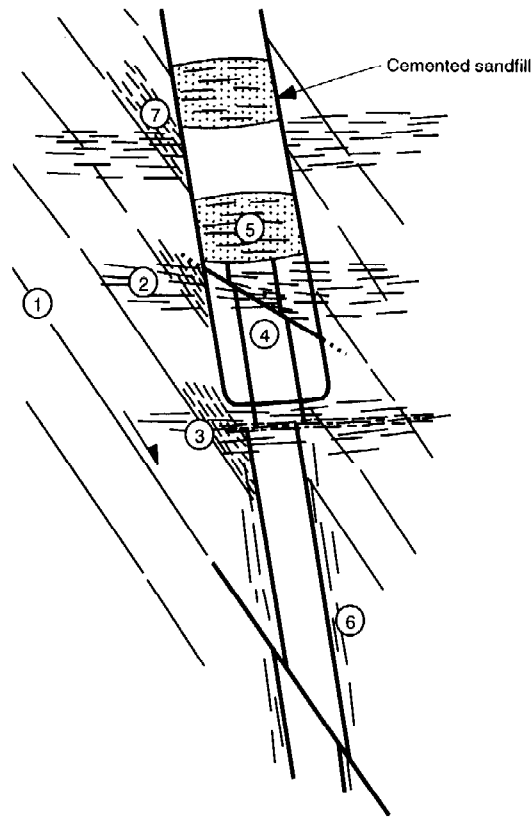
Figure 6. Cross section of Lucky Friday vein identifying mining-induced structures. 1, Bedding fault; 2, flat extension fractures; 3, shear-activated zone of closely spaced extension fractures; 4, thrust fault-shear rupture in face; 5, flat fractures in sandfill; 6, galena-filled stringers; 7, delaminated quartzite bedding.

The various mining-induced fractures, bedding plane slips, and shear ruptures seen at the Lucky Friday Mine are summarized in Figure 6.

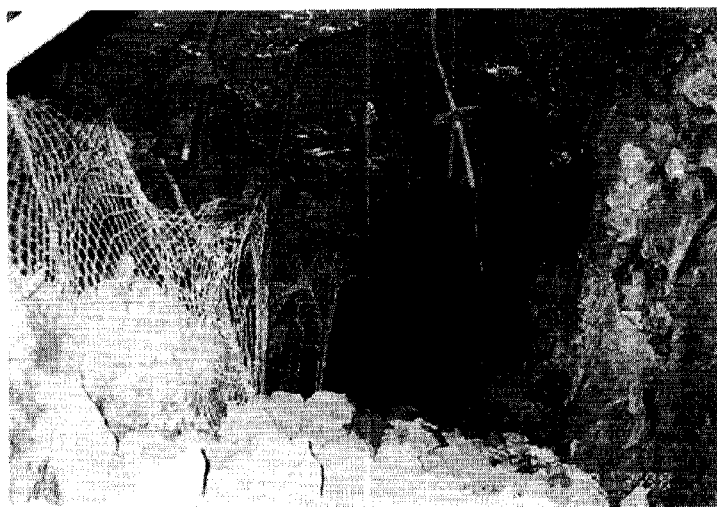
Figure 7. Rock burst damage in the 5750-05 stope. Note that both ribs and the overhead sandfill were damaged.

Rock burst damage may affect either ribs, the cemented sandfill, or the sill, and may involve several of these locations in the same event (Fig. 7). A common pattern of damage is one that affects the lower footwall rib and adjacent sill and the diametrically opposite upper hanging wall rib and the adjacent sandfill. In these cases, damage in the hanging wall frequently extends a short distance up the side of the sandfill. Such damage resembles the pattern formed

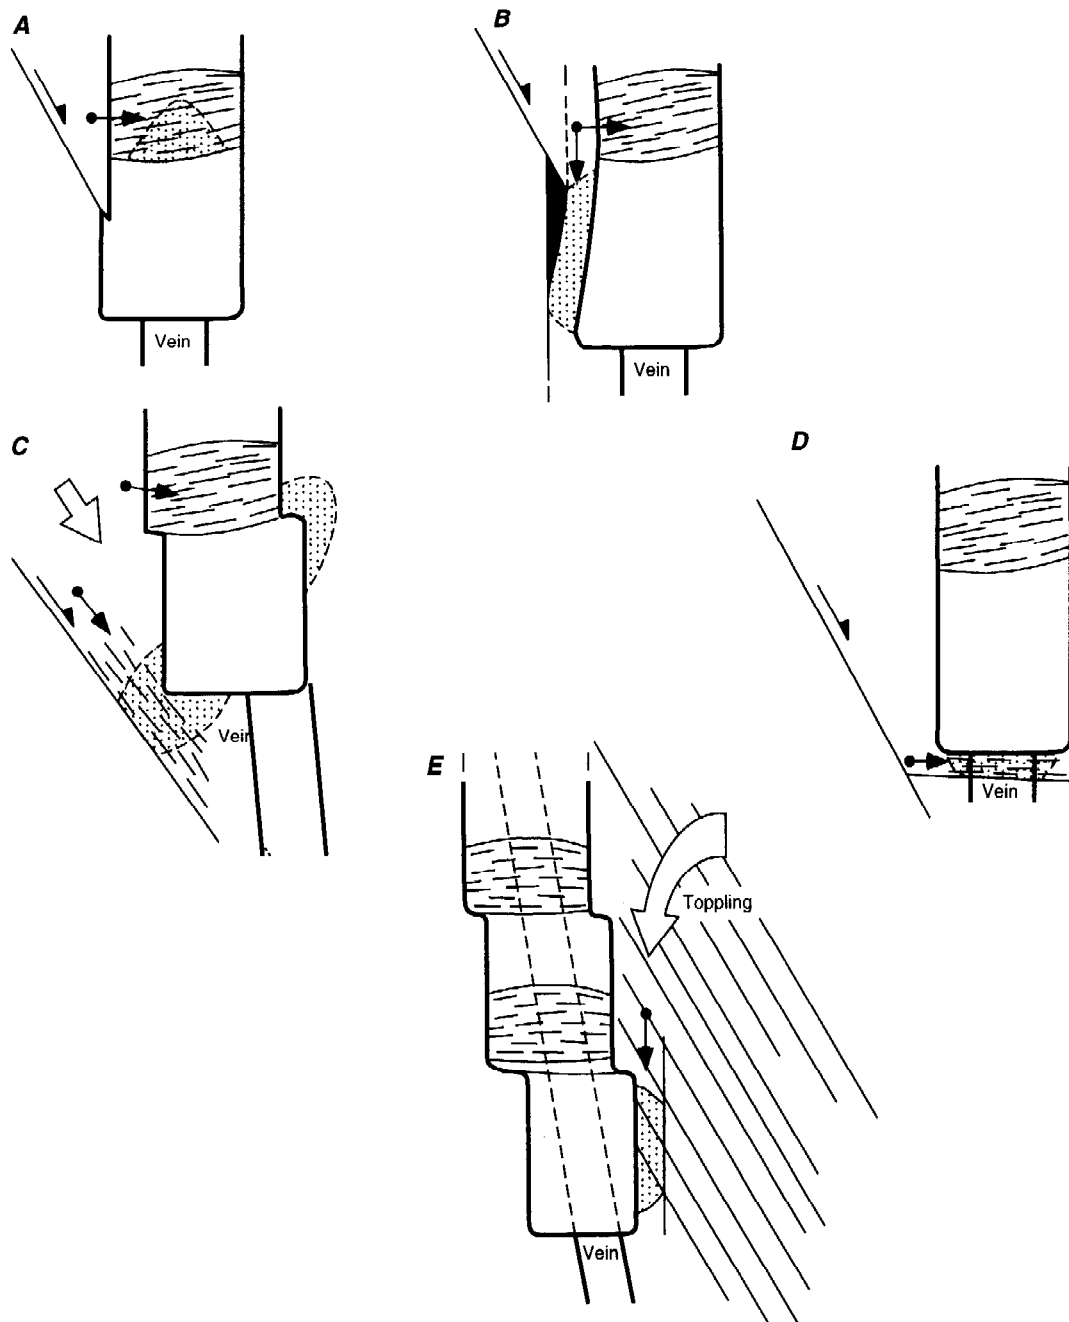
Figure 8. Interpretations of rock bursts in stopes caused by movement within the surrounding wall rock. Stippled areas indicate rock burst locations; arrow with ball identifies inferred direction of shortening responsible for damage at sites.

- A, Bedding slip identifies inferred direction of shortening responsible for damage at sites;
- B, bedding slip that fails to cut rock layers in rib compresses both the rib and the sandfill;
- C, shortening parallel to bedding delaminates quartzite bed at sill and damages upper hanging wall rib at sandfill;
- D, bedding slip compresses sill;
- E, inferred toppling in hanging wall increases vertical stress concentration along hanging wall rib.

Progressive movements in the footwall of the Lucky Friday vein generally cause a reduction in the physical dimensions of the stope. Compression of sandfill is a necessary and obvious consequence of downward bedding slip. However, bedding slip may also reduce various stope dimensions in a variety of other ways (Fig. 8). Except for bursts that affect the hanging wall rib, shortening of stope margins is likely to be a consequence of normal slip on bedding planes. The nature of the resulting damage depends partly on the elevation at which a particular slip intercepts a stope. If the slip plane intercepts the rib, only the sandfill may be affected (Fig. 8A). However, a bedding plane slip that fails to pass through relatively tabular rock layers formed between a stope and weak, galena-filled stringers may cause shortening and failure of the rock while compressing the sandfill (Fig. 8B). Bedding slips that intersect the underlying sill may concentrate stress at the sill-footwall junction and fracture quartzite along its internal laminations, enabling the layers to buckle in a rock burst (Fig. 8C). However, the diametrically opposite corner, at the juncture of the hanging wall rib and the sandfill, probably fails as a result of weakening by earlier fracturing.

The high horizontal component of in situ stress documented at the mine may be enough to cause mining-induced extension fractures and shear ruptures to form in the sill and for slip to take place on these fractures without associated bedding plane slip. However, bedding slip could also promote formation of fractures and thereby contribute to sill bursts (Fig. 8D).

Movements associated with bursts that affect the hanging wall rib have not been documented. It is likely that these bursts are promoted by high vertical stress in the hanging wall rib resulting from toppling of overlying strata toward the mined-out vein (Fig. 8E).
