NJ FACE INVESTIGATION REPORT

FACE 13-NJ-059

Batch Maker Dies after Toxic Exposure to Toluene Vapor

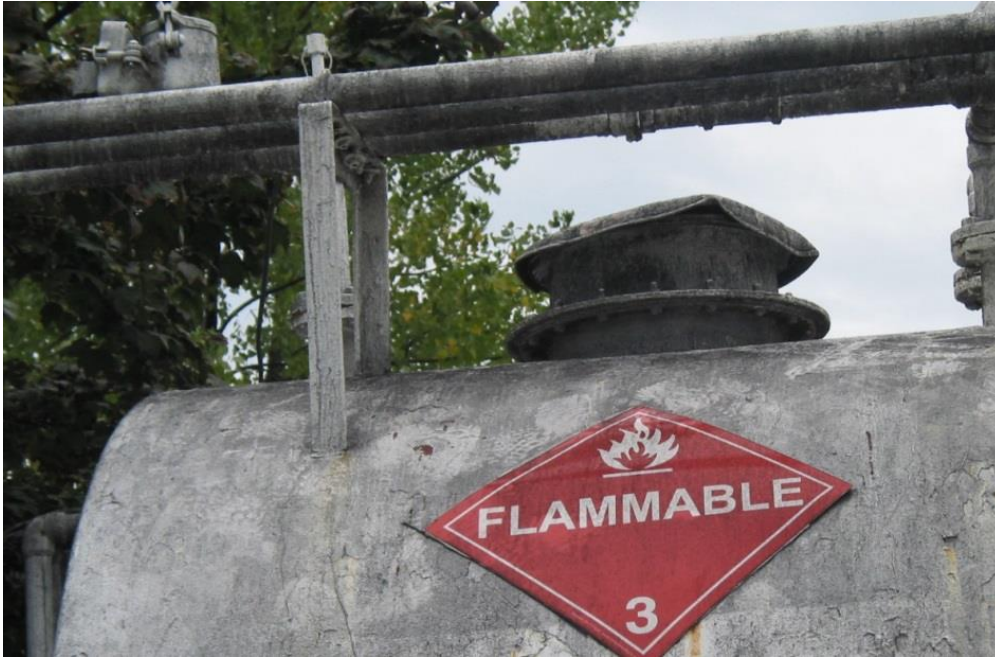
FIGURE 2. View of access port on top of tank.

The incident occurred on an extremely hot summer day (approximately 95° F at the time of the incident, wind speed up to about 12 mph), with no significant precipitation recorded. The incident site was located in the backyard of a manufacturing plant in northern NJ. The company manufactures varnishes, lacquers, enamels and other coatings. A total of 12 nonunion workers are employed on site. The incident occurred on the top of a 37-year-old, 6,000-gallon above-ground storage tank, separated into three 2,000 gallon sections used for storage of toluene, ethyl acetate, and butyl acetate (Figure 1). The cylindrical tank was 16 feet (192 inches) in length by eight feet (96 inches) in depth. The tank access was an 18-inch diameter access port, 12 inches in height (Figure 2). The total distance from the tip of the port to the bottom of the tank was nine feet (108 inches).

Discussion: According to 1910.146(b), entry into a confined space is *considered to have occurred as soon as any part of the entrant's body breaks the plane of an opening into the space.*¹ As such, the job task of opening the hatch and inserting the stick into the tank is considered a confined space entry. The victim and the coworker would open the access port and lower the stick down to the bottom of the tank. Since the stick was eighty-four inches long, and the distance from the top of the hatch to the bottom of the tank was nine feet, the workers had to reach two feet into the tank in order to obtain an accurate volume measurement.

NJ FACE recommends developing a method of determining the volume of the liquid in the tank without entry. This can be accomplished in many ways, including retrofitting the tank with a small, sealed window for external view, fixing or replacing the volume gauges, or the creation of a permanent system that would indicate the remaining volume without the need for manual gauging. If an alternative method cannot be developed, the employer must comply with OSHA's confined space entry standard (CFR 29, 1910.146).

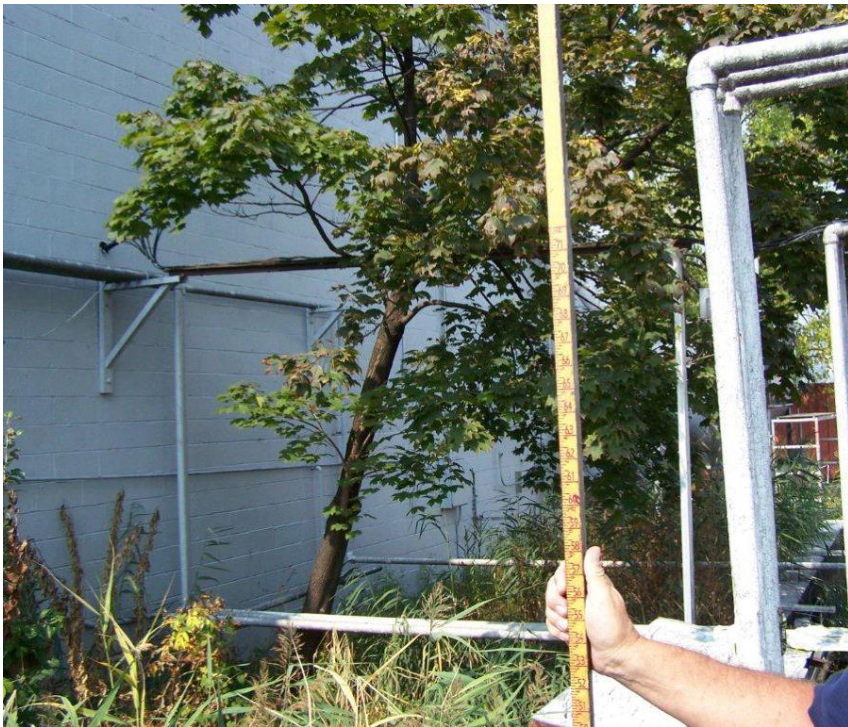
Figure 3. Eighty-four-inch-long wooden measuring stick used to manually gauge the volume of the remaining liquid in the tank.

Two batch makers were trained by the plant manager to measure the volume of liquid in each section by using an 84-inch-tall wooden measuring stick (Figure 3). Measurements were taken either daily or every other day in order to determine if additional solvent needed to be ordered. The tank-level gauges were not functioning, and volume measurements had been conducted manually for approximately the past 30 years.
