Preprint 01-113

"ADVANCE AND RELIEVE" MINING, A METHOD TO MITIGATE THE AFFECTS OF HIGH HORIZONTAL STRESS ON THE MINE ROOF

D. R. Dolinar, T. P. Mucho, and D. C. Oylar
Natl Inst for Occupatnl Sfty and Health
Pittsburgh, PA, USA

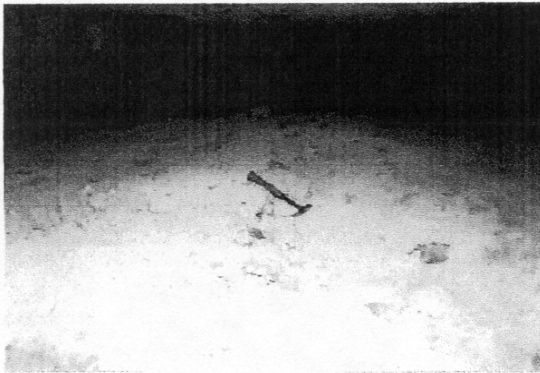
Figure 12. Floor heave experienced in E15 panel

With the start of "advance and relieve" pillaring in both panels E15 and E17, significant floor heave developed. For these panels, the floor geology consisted of 0.3 m to 0.6 m of shale underlain by 1.2 to 1.5 m of fireclay while the overburden averaged 210 m. Figure 12 shows typical floor heave that occurred. Systematic roof to floor convergence measurements were made in the intersections of the belt, L1 and L2 entries along the length of each panel.

The maximum floor heave occurred in both panels during the first 245 m of "advance and relieve" pillaring. In E15 the average heave rate in this panel section was 0.6 cm/day, while in E17 the average rate was 0.96 cm/day. These rates were maintained for periods of up to 40 to 60 days before leveling off. In places, 50 to 75 cm of floor heave resulted. The floor heave occurred across the panel width and was not confined to the area adjacent to the cave. Figure 13 shows the pattern of floor heave over time across the E17 panel 60 m in by the start of pillaring. The accelerated rate of floor heave shown in figure 13 after 115 days is the result of retreat mining in the

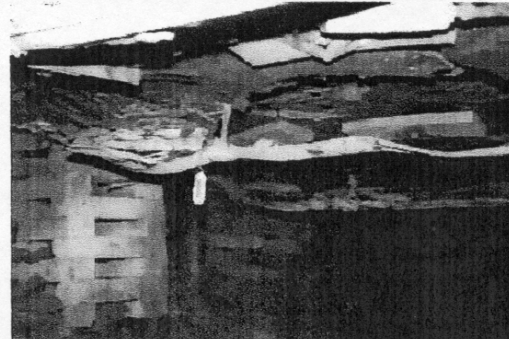
Figure 17. Rear abutment stress damage in L1 entry

To rehabilitate the damaged roof, cribs, posts and cable bolts were used as supplemental support in the R1 entry and across the panel along the narrow zone of damage. Similar, though not as severe damage was seen outby the cave in E17. Again supplemental support was used to control the stress damage. In E17 the damage approached but did not reach the mains.
