A mining research contract report
FEBRUARY 1983

EVALUATION OF THE BLACK RIVER MINE TELECOMMUNICATION SYSTEM

Contract J0318074
Atlantic Research Corporation

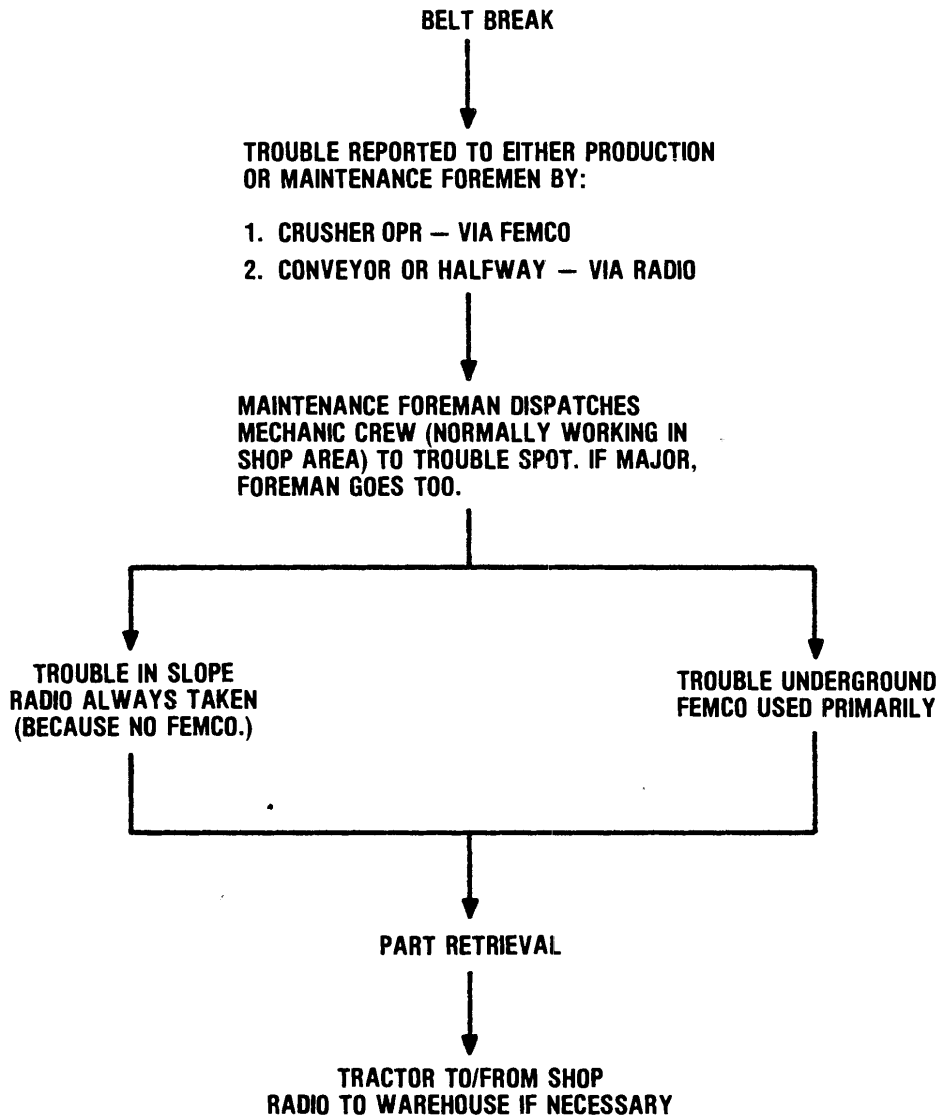
Figure 5-1. Procedure used for major production stoppage.

The use of communications in a typical unscheduled maintenance situation, such as a haulage belt break, is illustrated in Figure 5-1. The trouble is likely to be first observed by the crusher operator, the conveyor or the half-way observer. The crusher operator would normally report the problem via the Femco telephone at his work station. The conveyor, because he roams, would find it more convenient to report by radio. The half-way observer could use either, but typically uses radio.

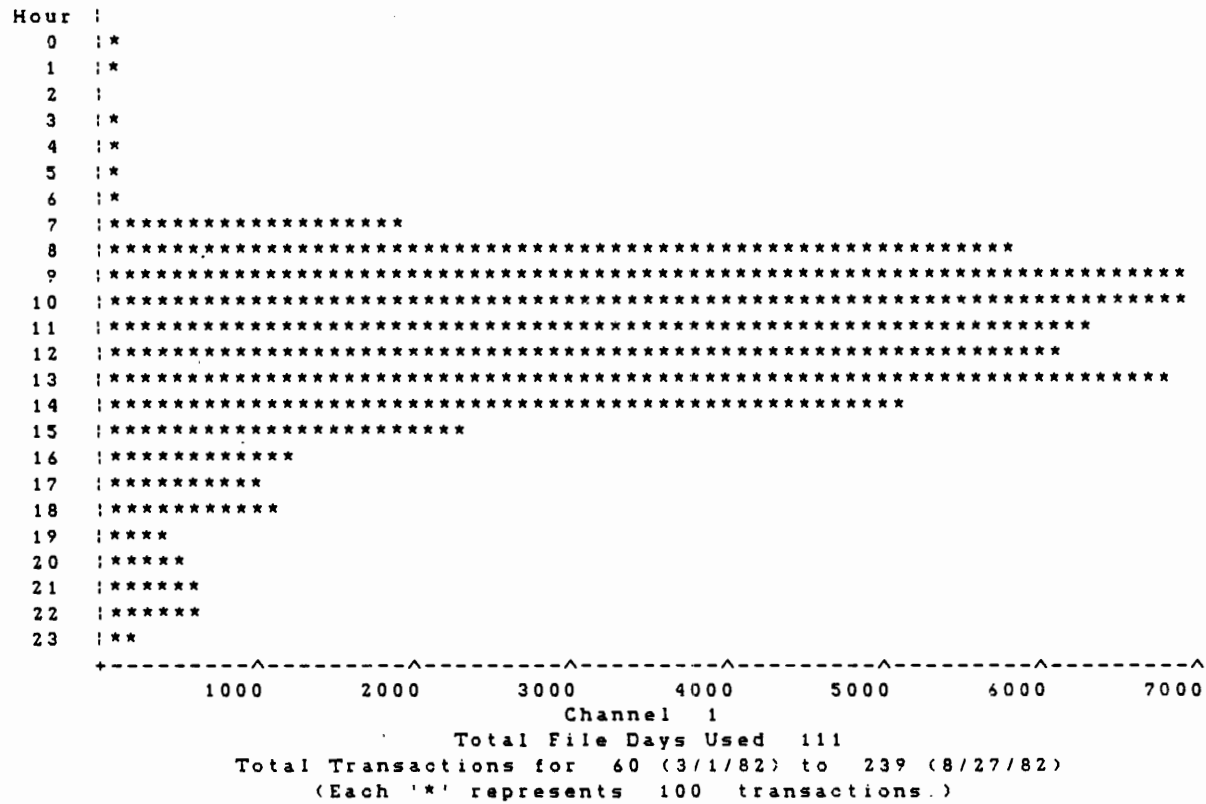
APPENDIX A
HISTOGRAPHS

The information in Appendix A shows generally that use of the radio channels is greater during the day shift and particularly from 9 AM to about 3 PM. However, daily variation from the norm were noted to be considerable.

The data collected shows generally that use of the radio channels is greater during the day shift and particularly from 9 AM to about 3 PM. However, daily variation from the norm were noted to be considerable. The highest occupancy was noted to be 890 seconds (or $890/3600 = 24.7\%$) occurring on April 3. In one case, (August 5) peak traffic occurred in the 4 to 5 AM time block in connection with early morning maintenance activity. On one day only (less than 1% of the time) did the peak occupancy on channel 1 exceed 24% (24.7% on April 3). It exceeded 12% occupancy for less than 10% of the time. The median occupancy (exceeded 50% of the time) was 6%. Traffic on channels 2 and 3 was never more than a fraction of channel 1 traffic.

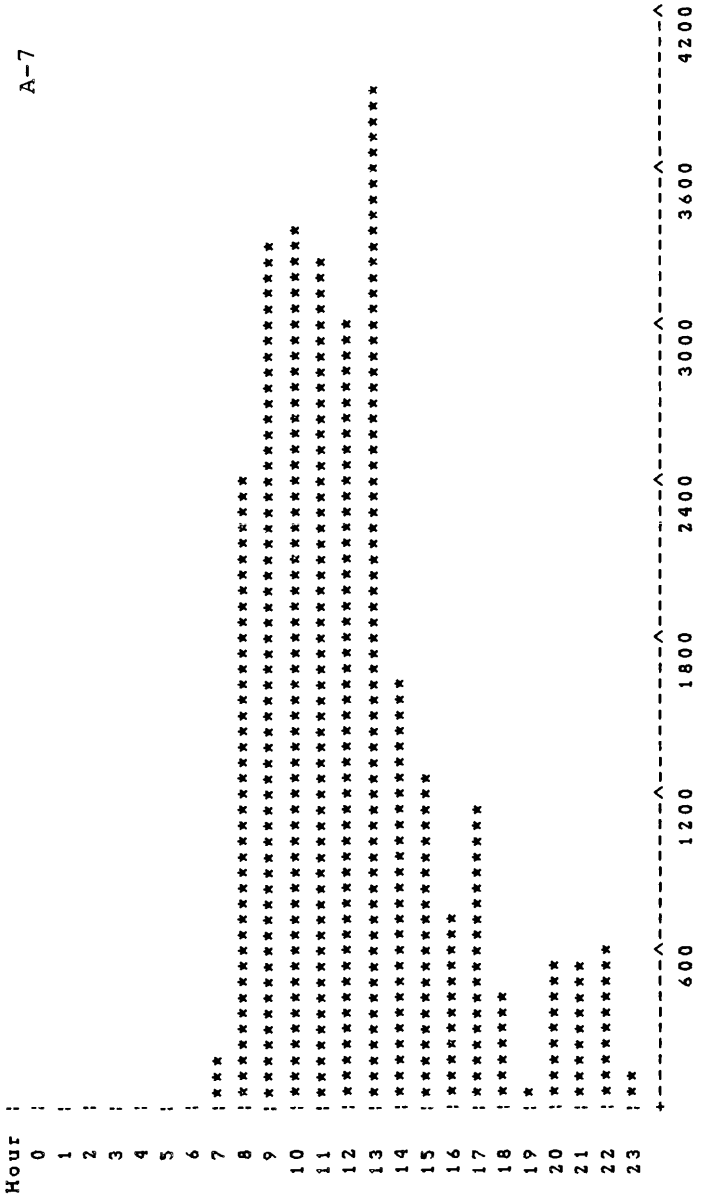
Channel 1
 Total File Days Used 23
 Total Seconds of Use for 60 (3/1/82) to 90 (3/31/82)
 (Each '*' represents 60 seconds of use.)

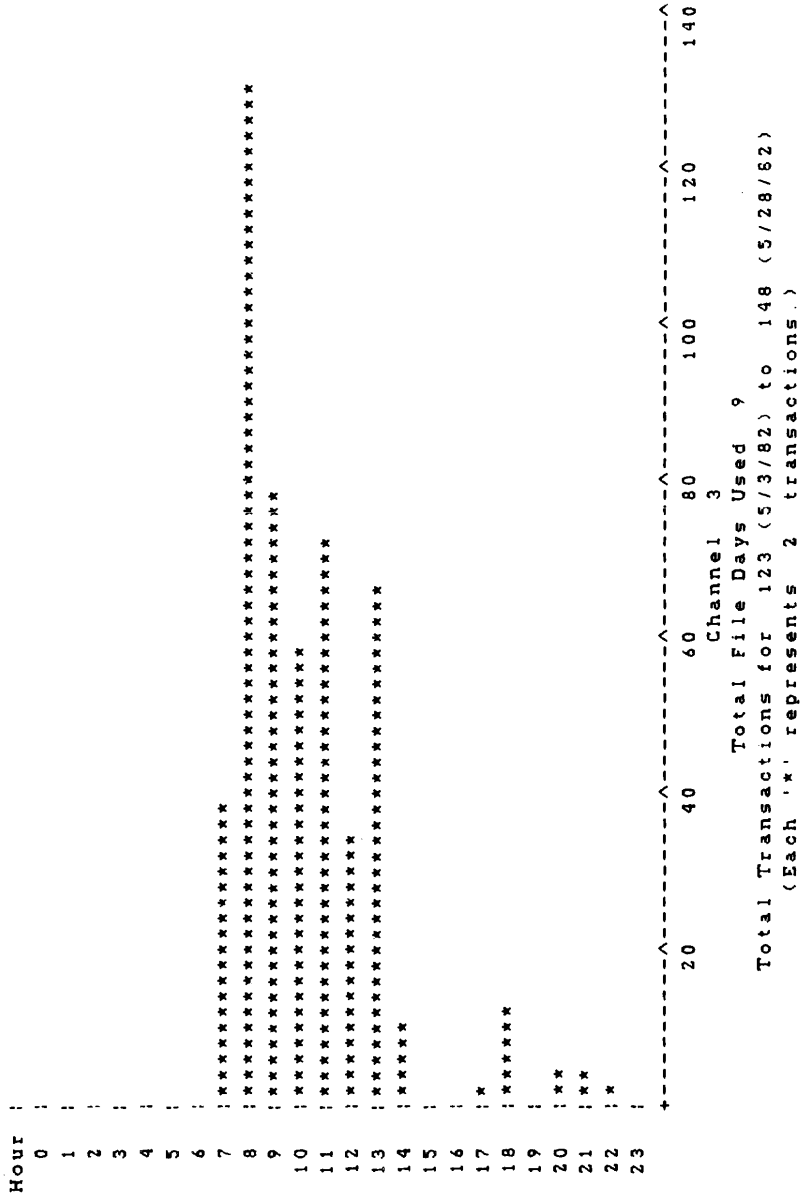
Hour :
0 :
1 :
2 :
3 :
4 :
5 :
6 :
7 : *****
8 : *****
9 : *****
10 : *****
11 : *****
12 : *****
13 : *****
14 : *****
15 :
16 :
17 :
18 : *****
19 :
20 : *****
21 :
22 :
23 :
-----^-----^-----^-----^-----^-----^-----^-----^-----^-----^
0.2 0.3 0.5 0.6 0.8 0.9 1.1
Channel 3
Total File Days Used 9
Average Percent of System Occupancy for 123 (5/3/82) to 148 (5/28/82)
(Each 'x' represents 0.015 percent.)

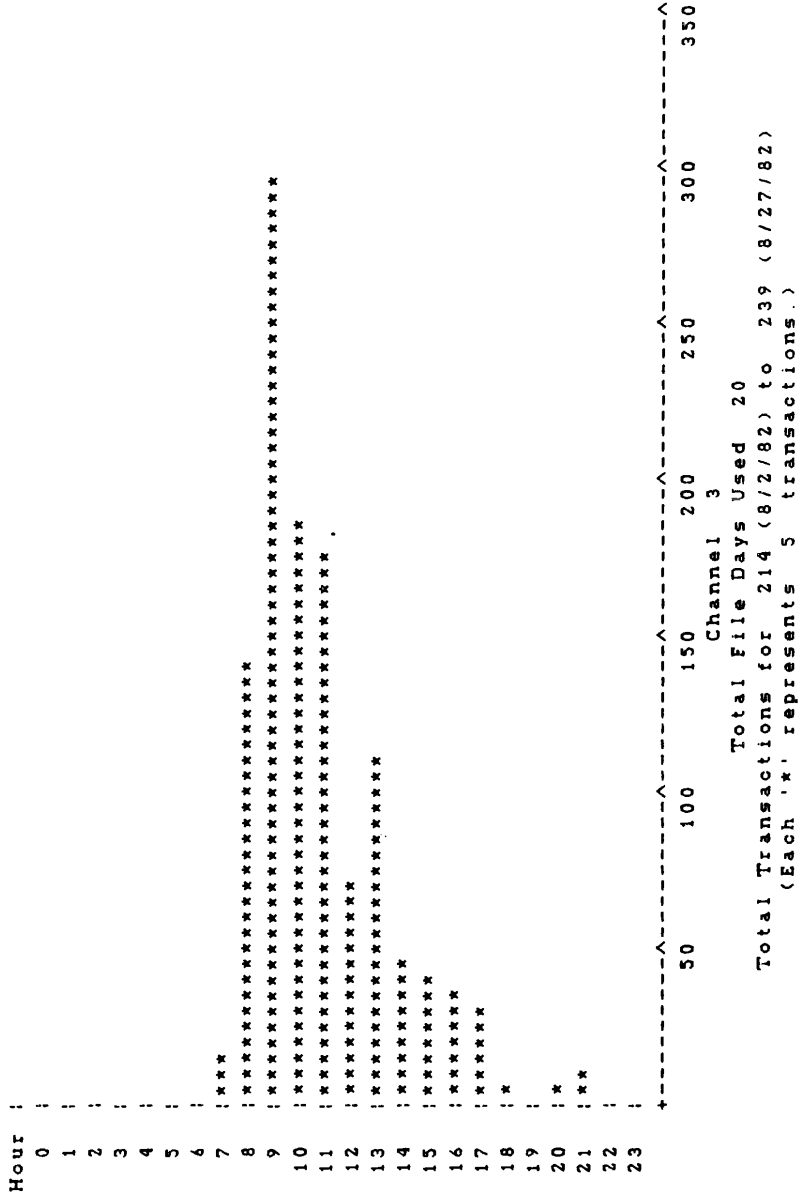
Channel 3
 Total File Days Used 20
 Average Percent of System Occupancy for 214 (8/2/82) to 239 (8/27/82)
 (Each '*' represents 0.015 percent.)
