**LINE OF DUTY
DEATH REPORT
REPORT SLIDES**

F2019-01

**Industrial Silo Fire and Subsequent
Explosion Kills One Firefighter and
Critically Injures Another - Iowa**

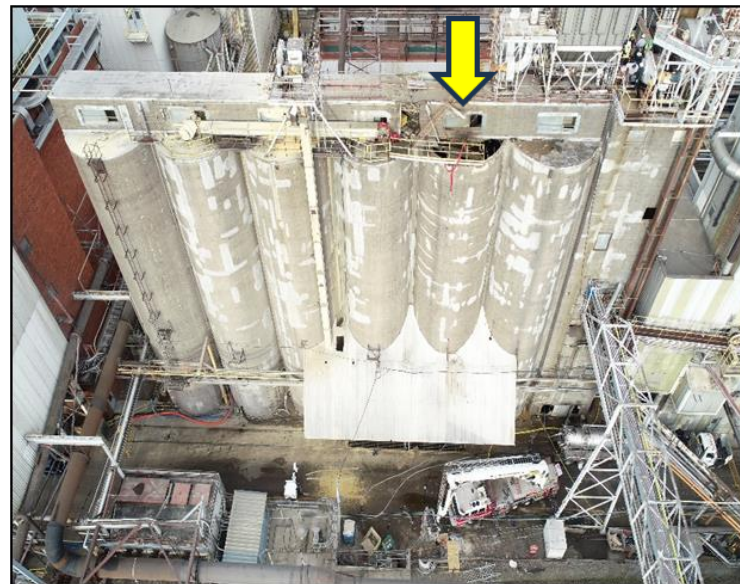
Six silos at a corn processing facility. Yellow arrow shows silo #2 whose top exploded approximately 3 hours after a corn pellet fire was discovered at the bottom of the silo. (Photo courtesy of the fire department)

- Facility employees informed Command that contractors had been working to remove an obstruction in the silo before the fire was discovered.
- Size-up from L54 revealed a smoldering silage fire in the bottom of silo #2.
- A tactical plan was initiated deploying L54's 1¾-inch hoseline from the below grade conveyor area, directing the water up into the silo.
- This plan was ineffective as L54 crews observed that air was being drawn/sucked into the silo and there was still active fire inside.
- This effort was abandoned at 06:42 hours and an alternative plan was developed involving flowing water through a 2ft-by-2ft access hatch on top of the silo using L54 as a standpipe and 50ft of 3-inch hose.

- Fire departments should train fire officers and firefighters on the hazards associated with different types of silos and the appropriate firefighting tactics, including any unique hazards posed by the silo contents.
- Fire departments should develop a pre-incident plan for all high-hazard occupancies in their jurisdictions.
- Governing municipalities (federal, state, regional/county, and local) should ensure the applicable fire and life safety codes are enforced at high-hazard occupancies such as agricultural and/or food processing facilities.
- Agricultural and/or food processing facilities should properly operate and maintain their silos and implement the applicable requirements of NFPA 61, Standard for the Prevention of Fires and Dust Explosions in Agricultural and Food Processing Facilities.

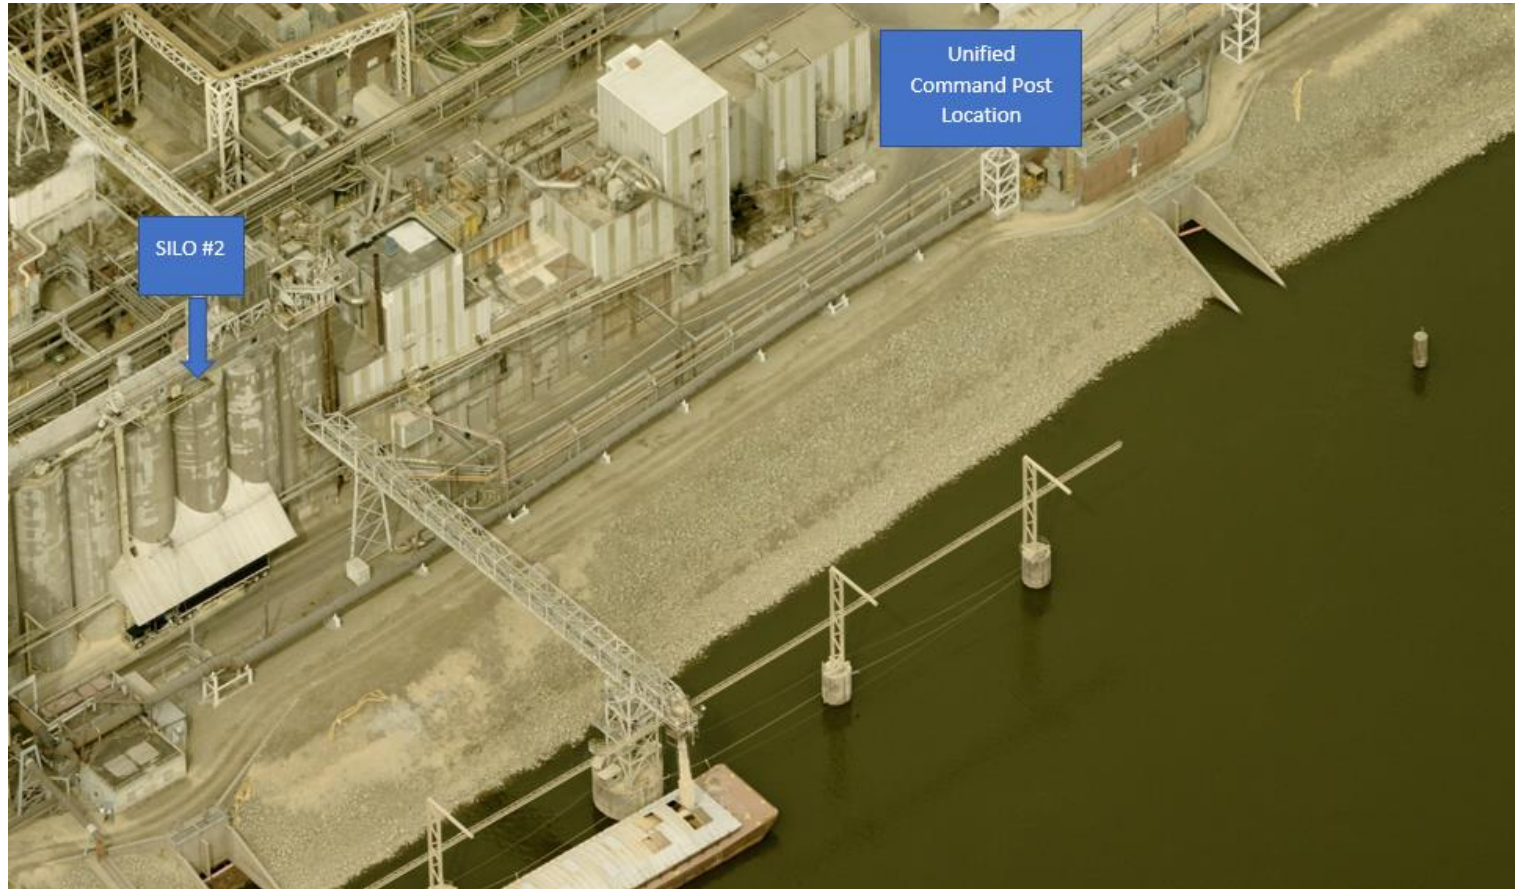
Location of silo #2 in relation to command post.
(Courtesy of the fire department)

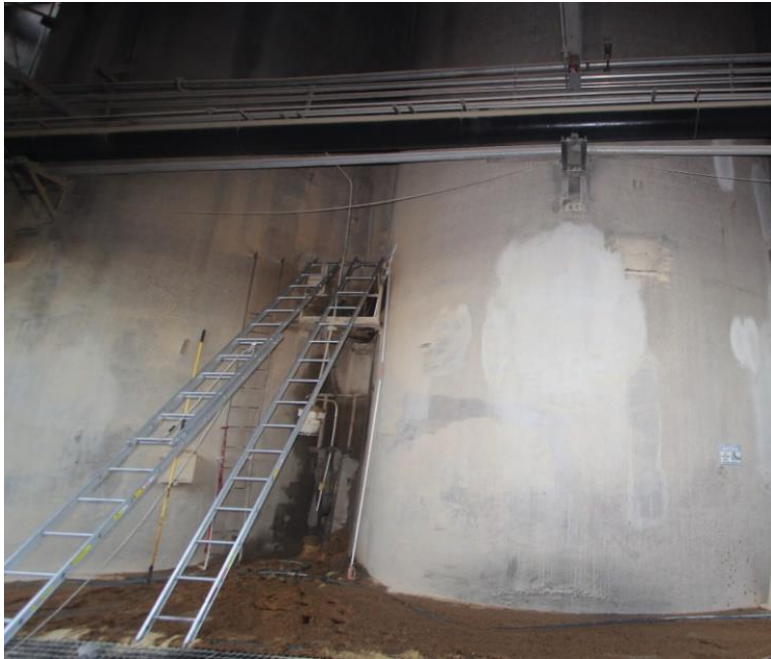
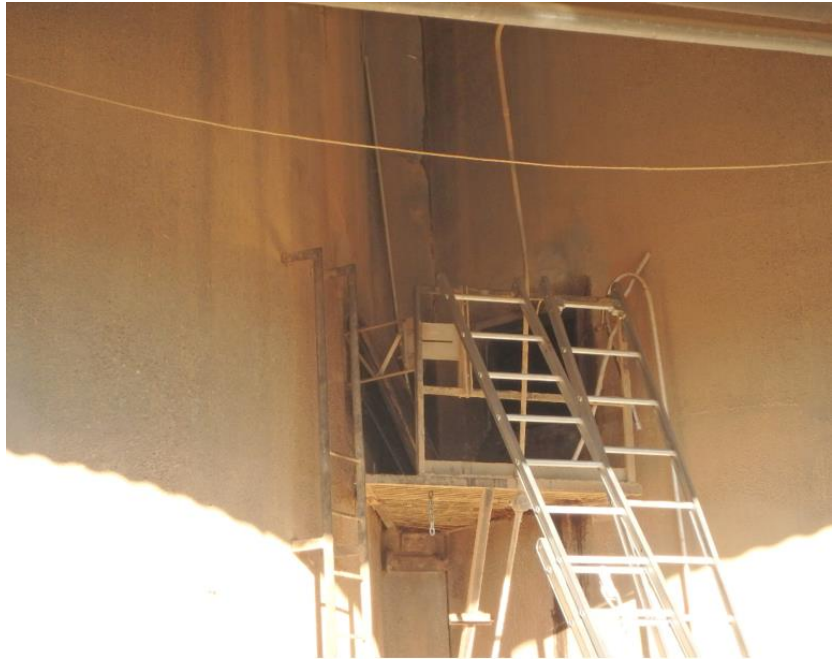
- This resulted in an explosion at the top of the silo which caused CO3 lieutenant to fall 85ft from the edge of the silo, landing on a fiberglass awning below, and then onto the ground.
- The explosion also catapulted CO3 firefighter into the air who then fell into silo #2, landing on the still smoldering pellets.
- CO3 firefighter was rescued from inside the silo using the side access hatch.
- After both were transported to the hospital, firefighting operations resumed, changing tactics multiple times, until the fire was fully extinguished at 15:15 hours.
- CO3 lieutenant died and the CO3 firefighter was hospitalized for three weeks before being discharged from the hospital on January 25, 2019.

Location and ladder configuration used to locate and rescue CO3 firefighter from inside silo #2.
(Courtesy of the fire department)
